# Newsletter of **Environmental, Disaster, and Crises Management Strategies**

Issue No.22 | March 2021

## The early March 2021 Thessaly earthquake sequence

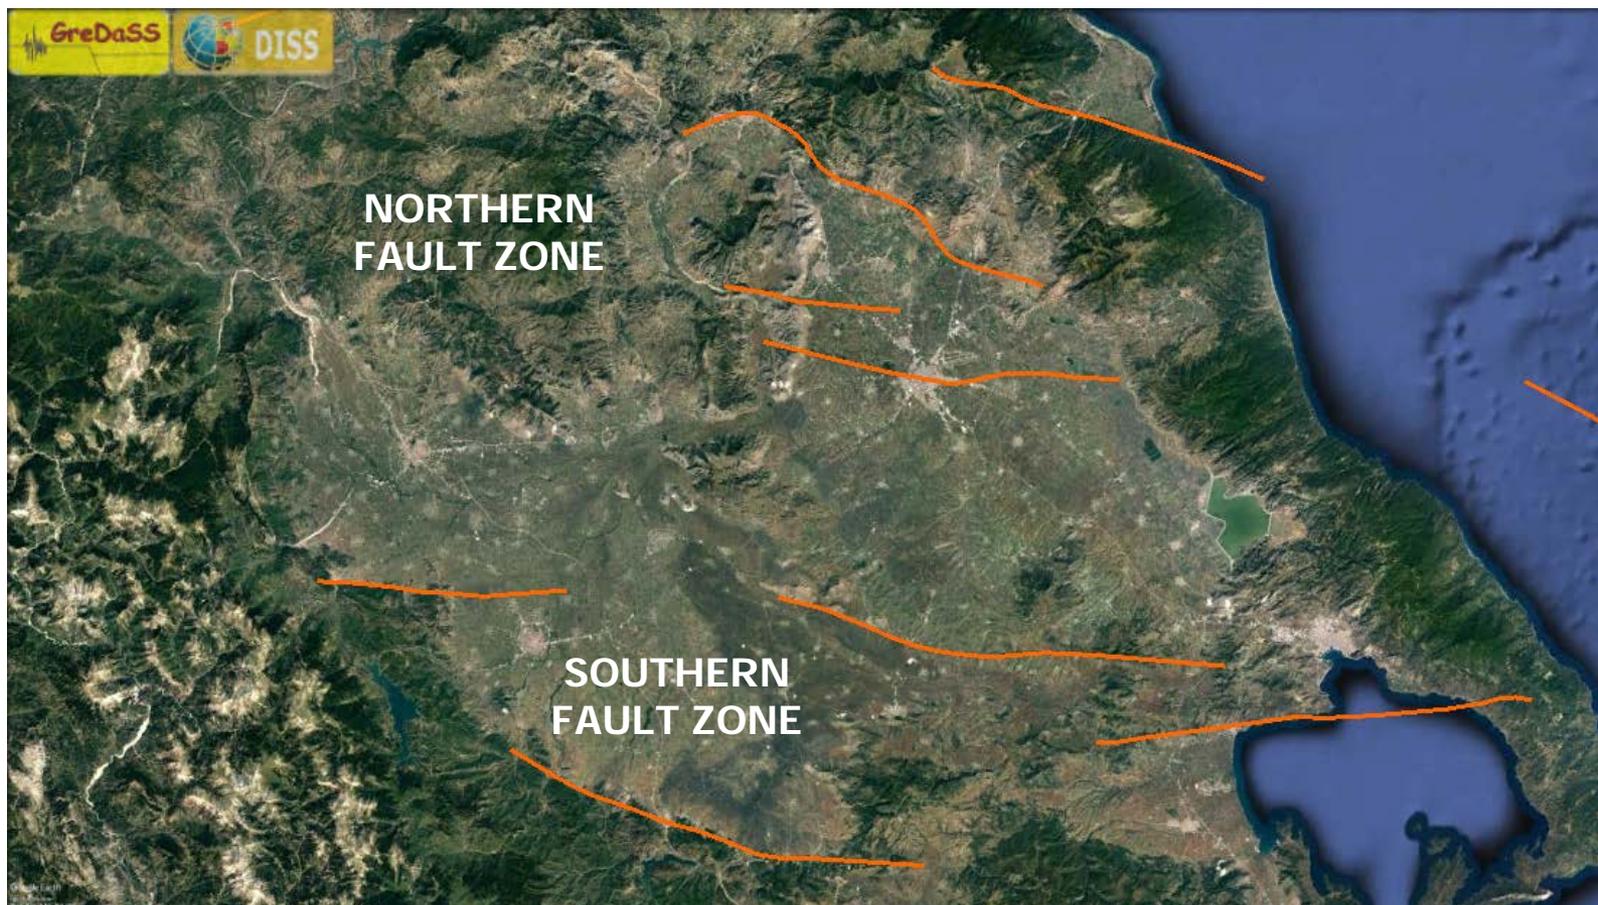
## **SEISMOGENIC SOURCES IN THESSALY BASIN BASED ON THE GREEK DATABASE OF SEISMOGENIC SOURCES**

The seismicity of Thessaly Basin is detected along two fault zones: the northern fault zone, which is associated with earthquakes with magnitudes up to 6.5 and the southern fault zone associated with earthquakes with magnitude up to 7.0.

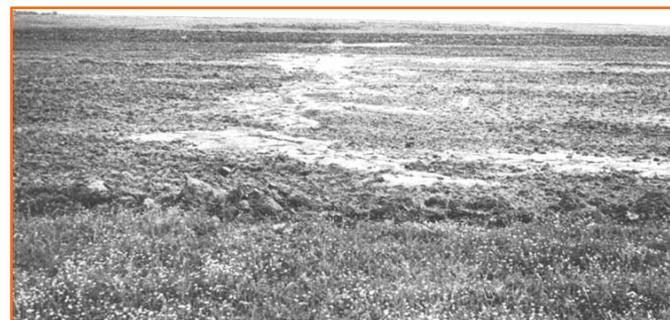
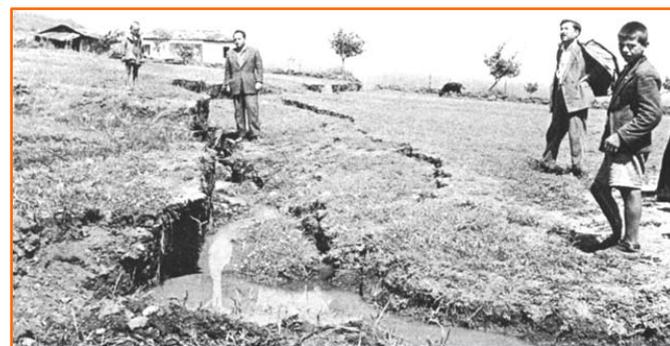
*Liquefaction and surface faulting induced by the 1954 Sofades earthquake*

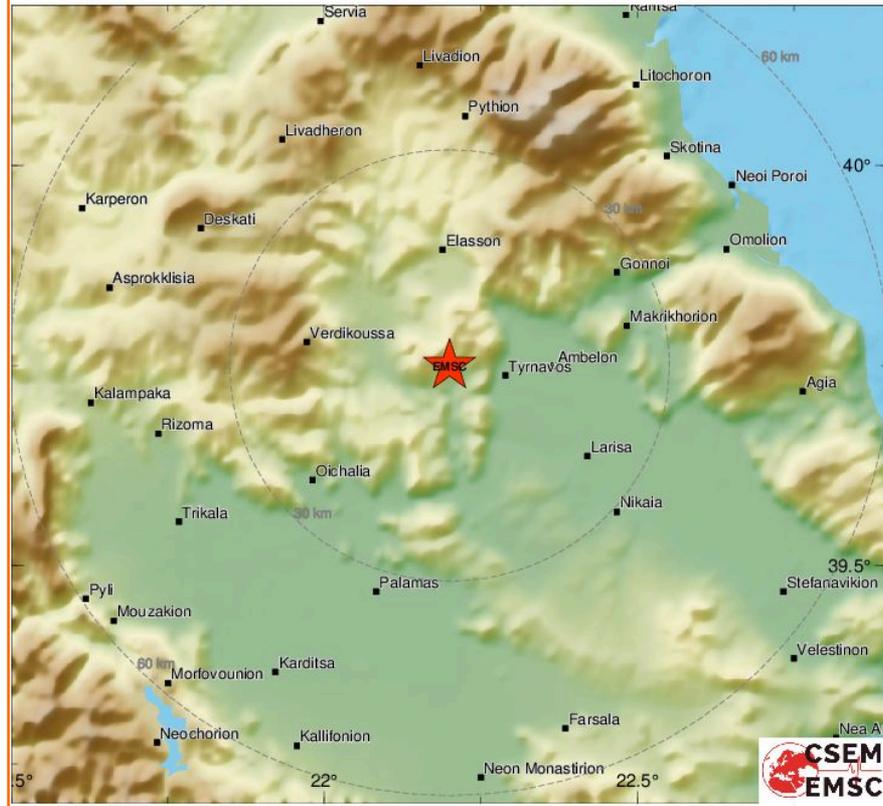
**M6.3 2021/03/03 - 10:16:08 UTC Lat 39.75 Lon 22.20 Depth 8.0 km**

22 km WNW of Larisa, Greece ( pop: 144,000 local time: 12:16 2021/03/03 )  
8 km W of Tyrnavos, Greece ( pop: 10,700 local time: 12:16 2021/03/03 )

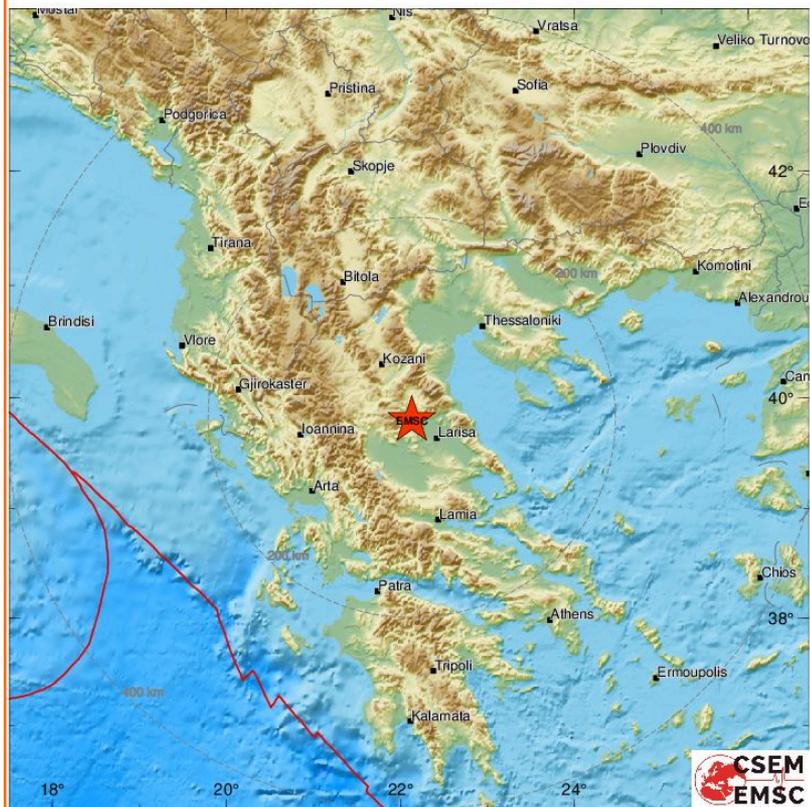
**M5.6 2021/03/04 - 18:38:18 UTC Lat 39.80 Lon 22.13 Depth 5.0 km**

31 km WNW of Larisa, Greece ( pop: 144,000 local time: 20:38 2021/03/04 )  
15 km WNW of Tyrnavos, Greece ( pop: 10,700 local time: 20:38 2021/03/04 )

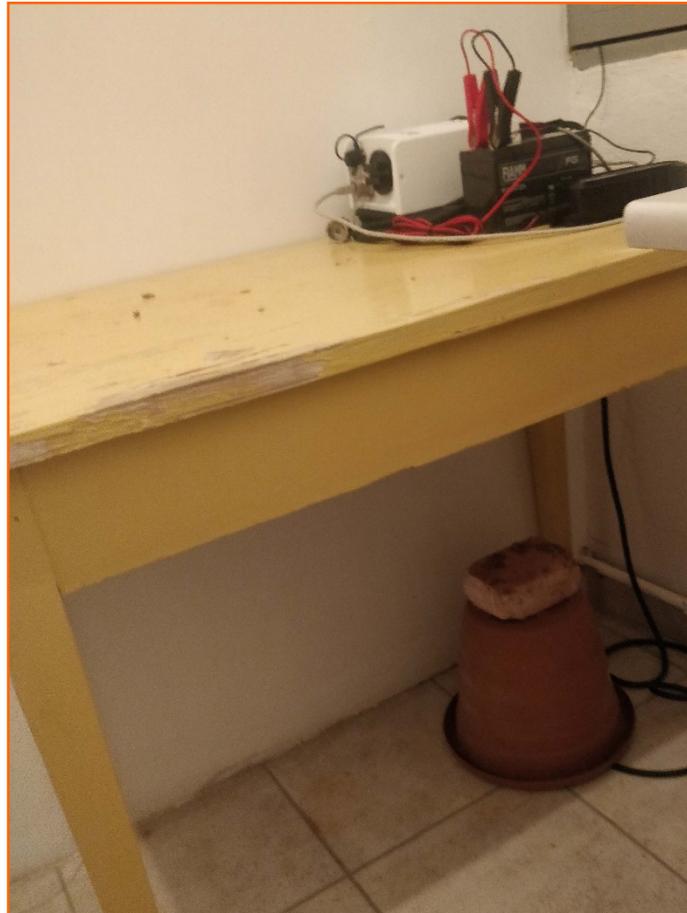
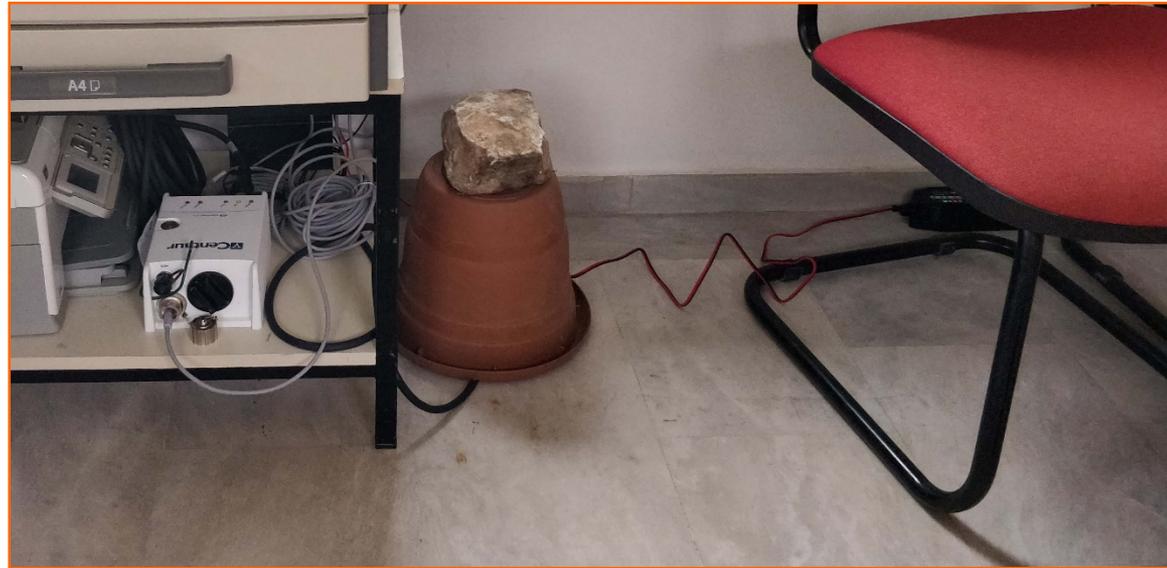
Indicative images from the installed seismographs of the temporary network for monitoring the post-earthquake sequence of the Tyrnavos – Ellassona earthquake.

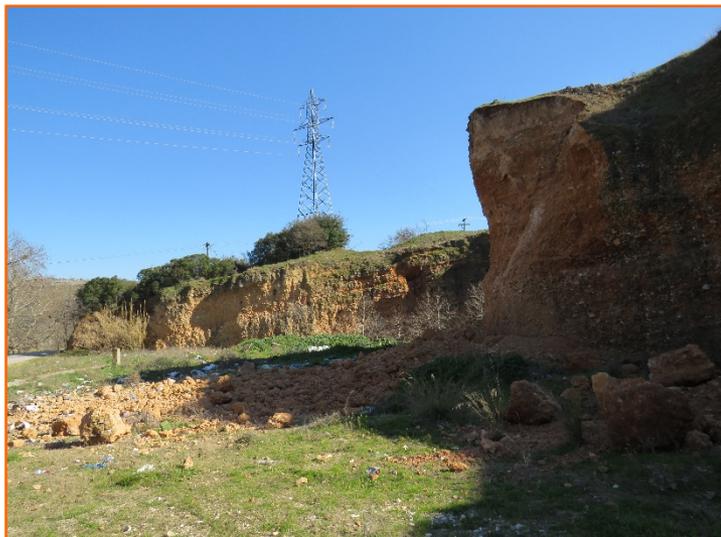
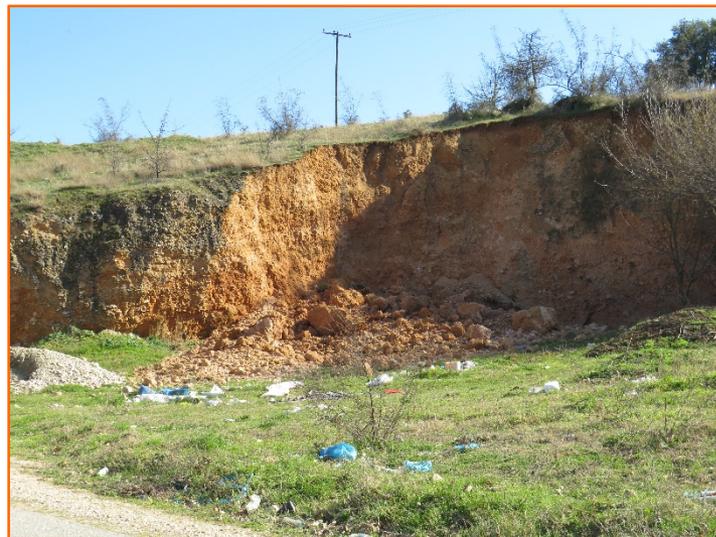
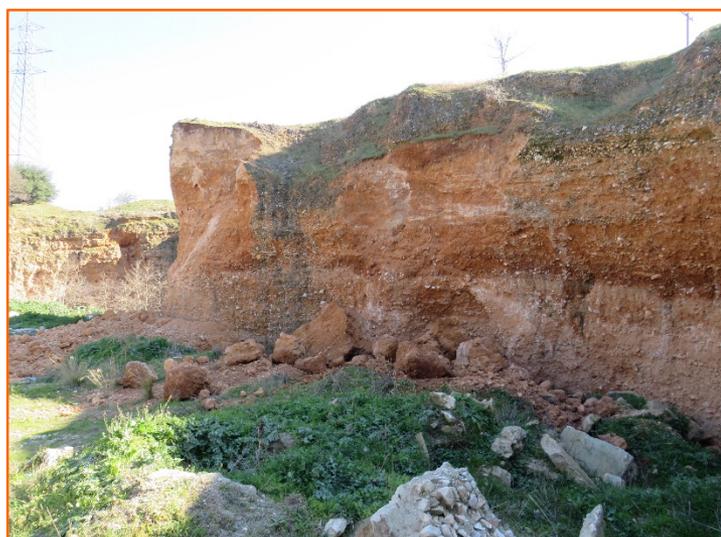
## SECONDARY EARTHQUAKE ENVIRONMENTAL EFFECTS SLOPE FAILURES

Rockfalls were generated along slopes in Damasi area. The affected slopes are composed of scree.

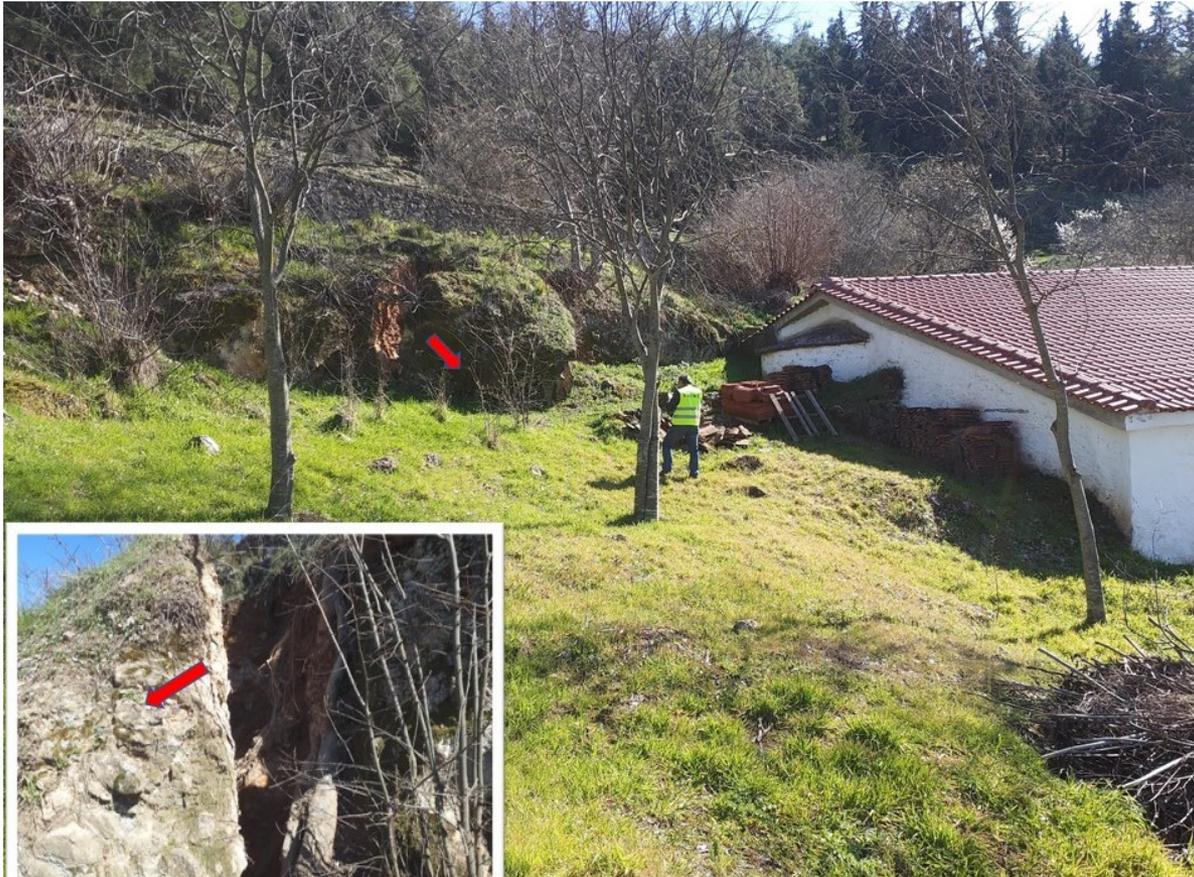
In Domeniko village of the Ellassona Municipality, close to the Byzantine church of Ayoi Anargyroi, a boulder of about five cubic meters was detached from the gneiss formation. This boulder is unstable and there is a risk of rolling down towards the church. The staff of the Hellenic Survey of Geology and Mineral Exploration proposed either removal of the boulder due to easy access or fragmentation with mechanical method.

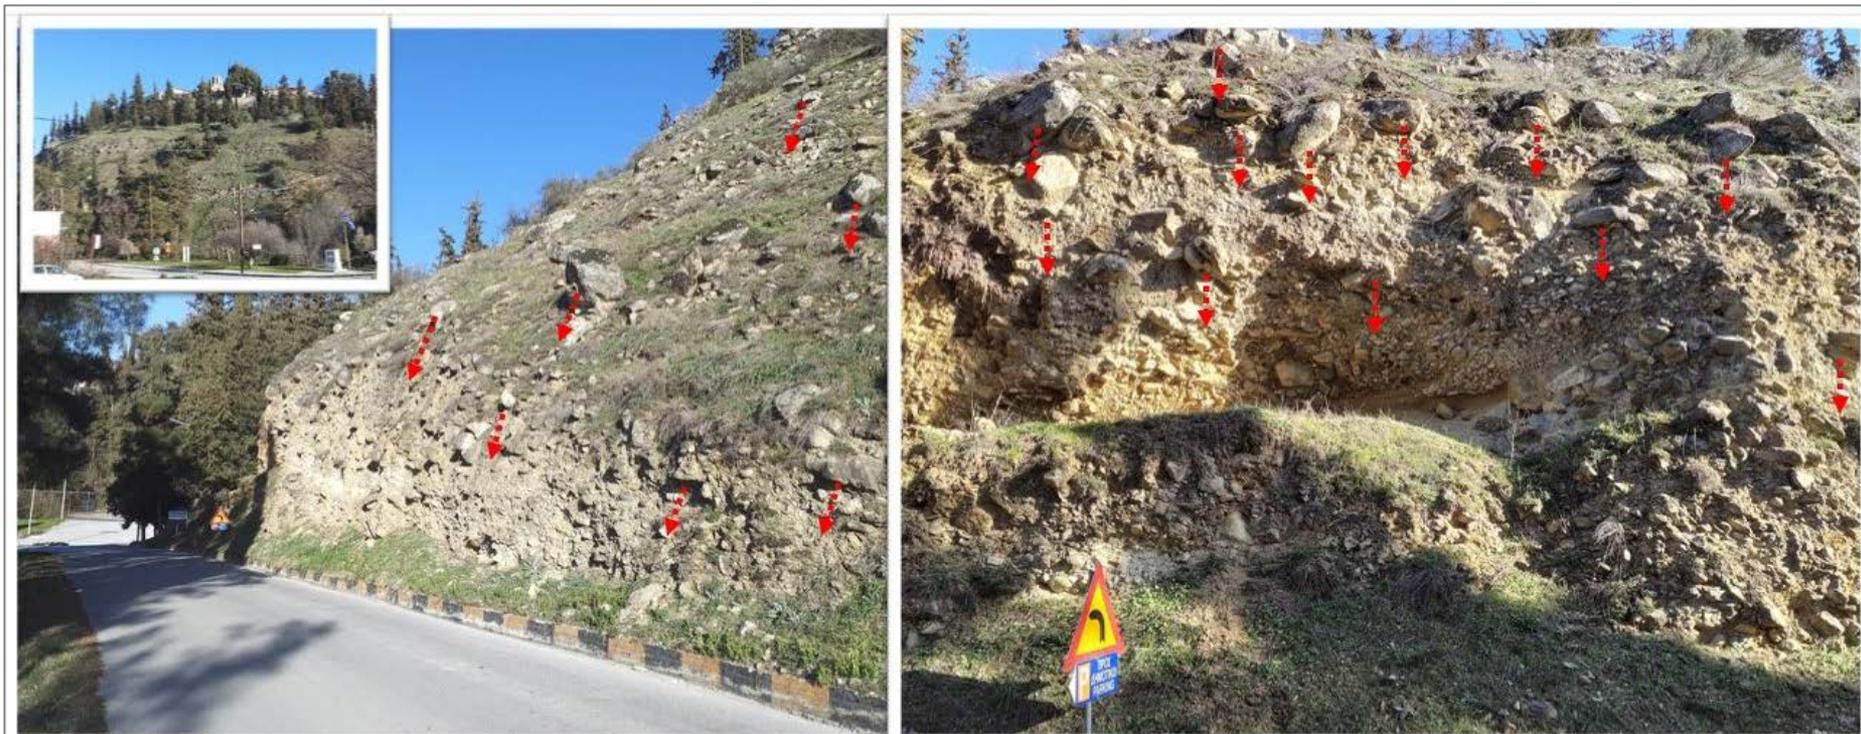
On the steep slopes of the provincial road downstream of the Holy Monastery of Panagia Olympiotissa, which is composed of river deposits, boulders of various sizes were detached.

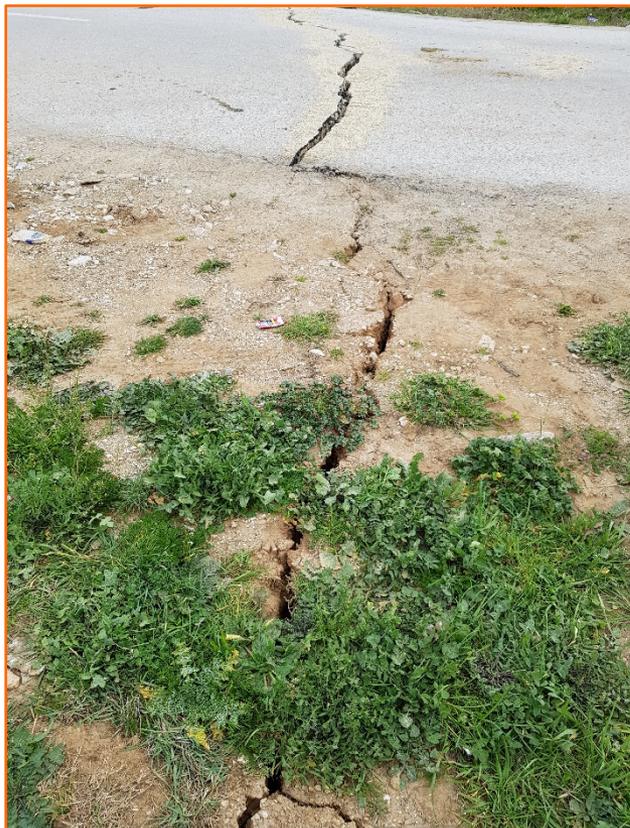
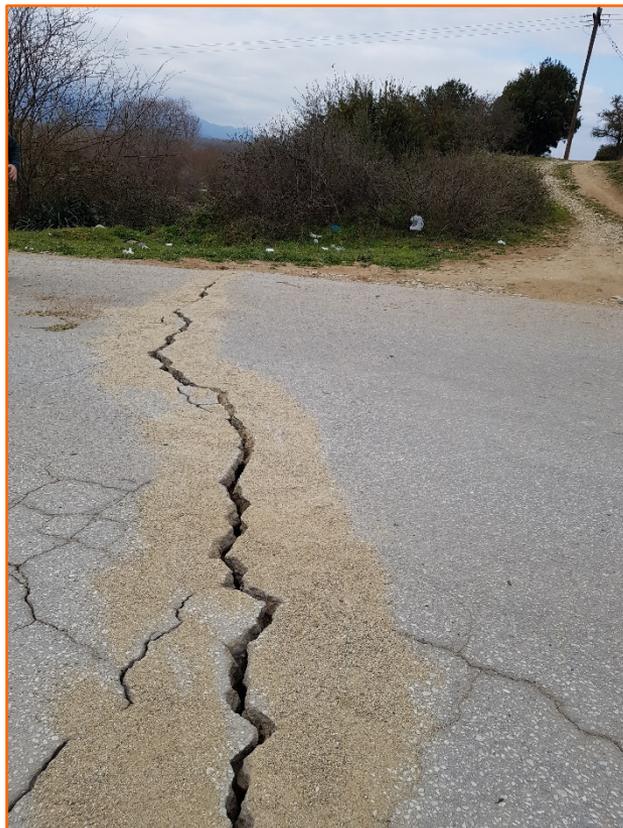
Extensive and deep ground cracks were also generated by the Mw=6.3 earthquake of March 3, 2021. Some were observed close to river beds along with ejected liquefied material (left, middle), while others were parallel to the seismic fault (Vlachogianni) as it is derived from the focal mechanisms provided by several seismological institutes and observatories.

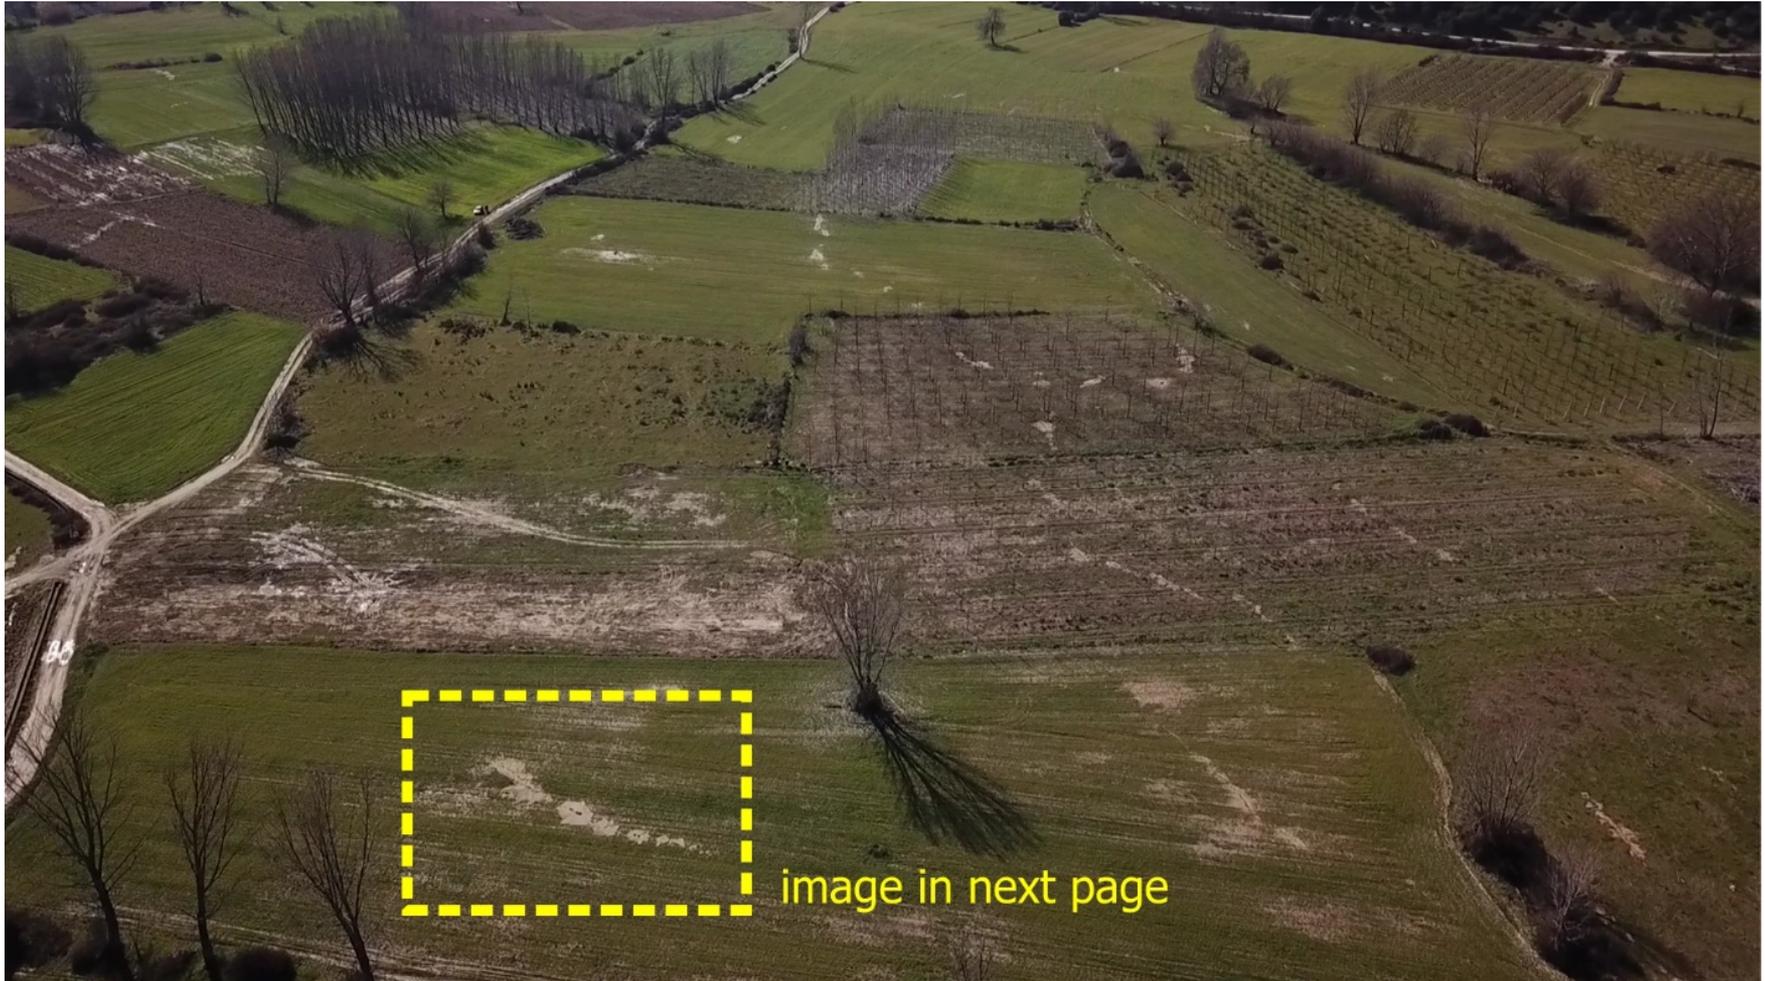
Extended liquefaction phenomena in the area located southeast of Vlachogianni village, east of the Titarissios River. The grey spots in the green fields correspond to ejected liquefied material.

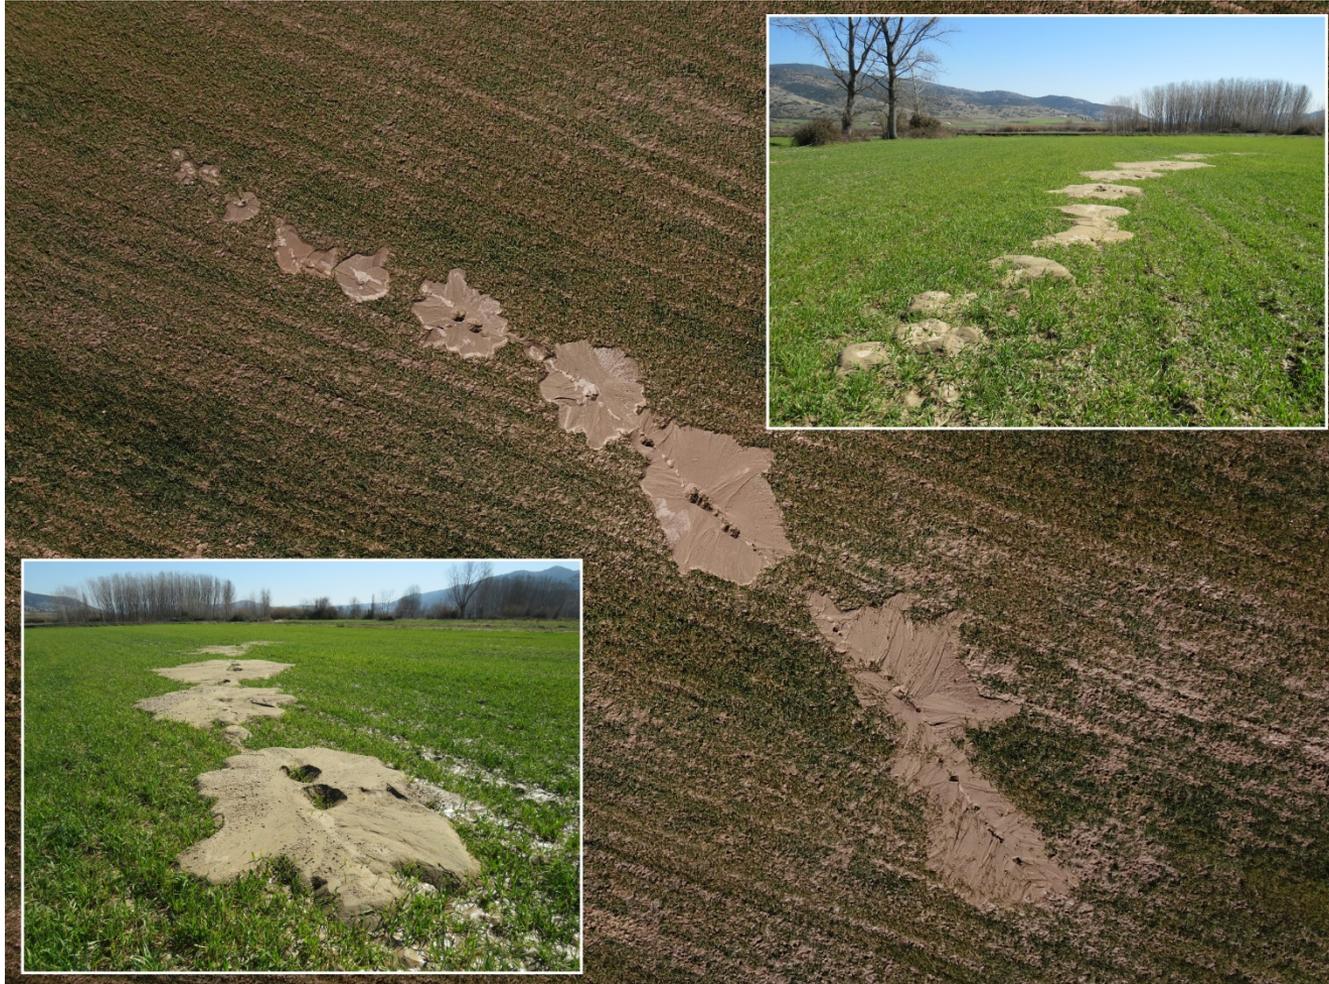
Sand boils along ground cracks in a field located southwest of Vlachogianni village

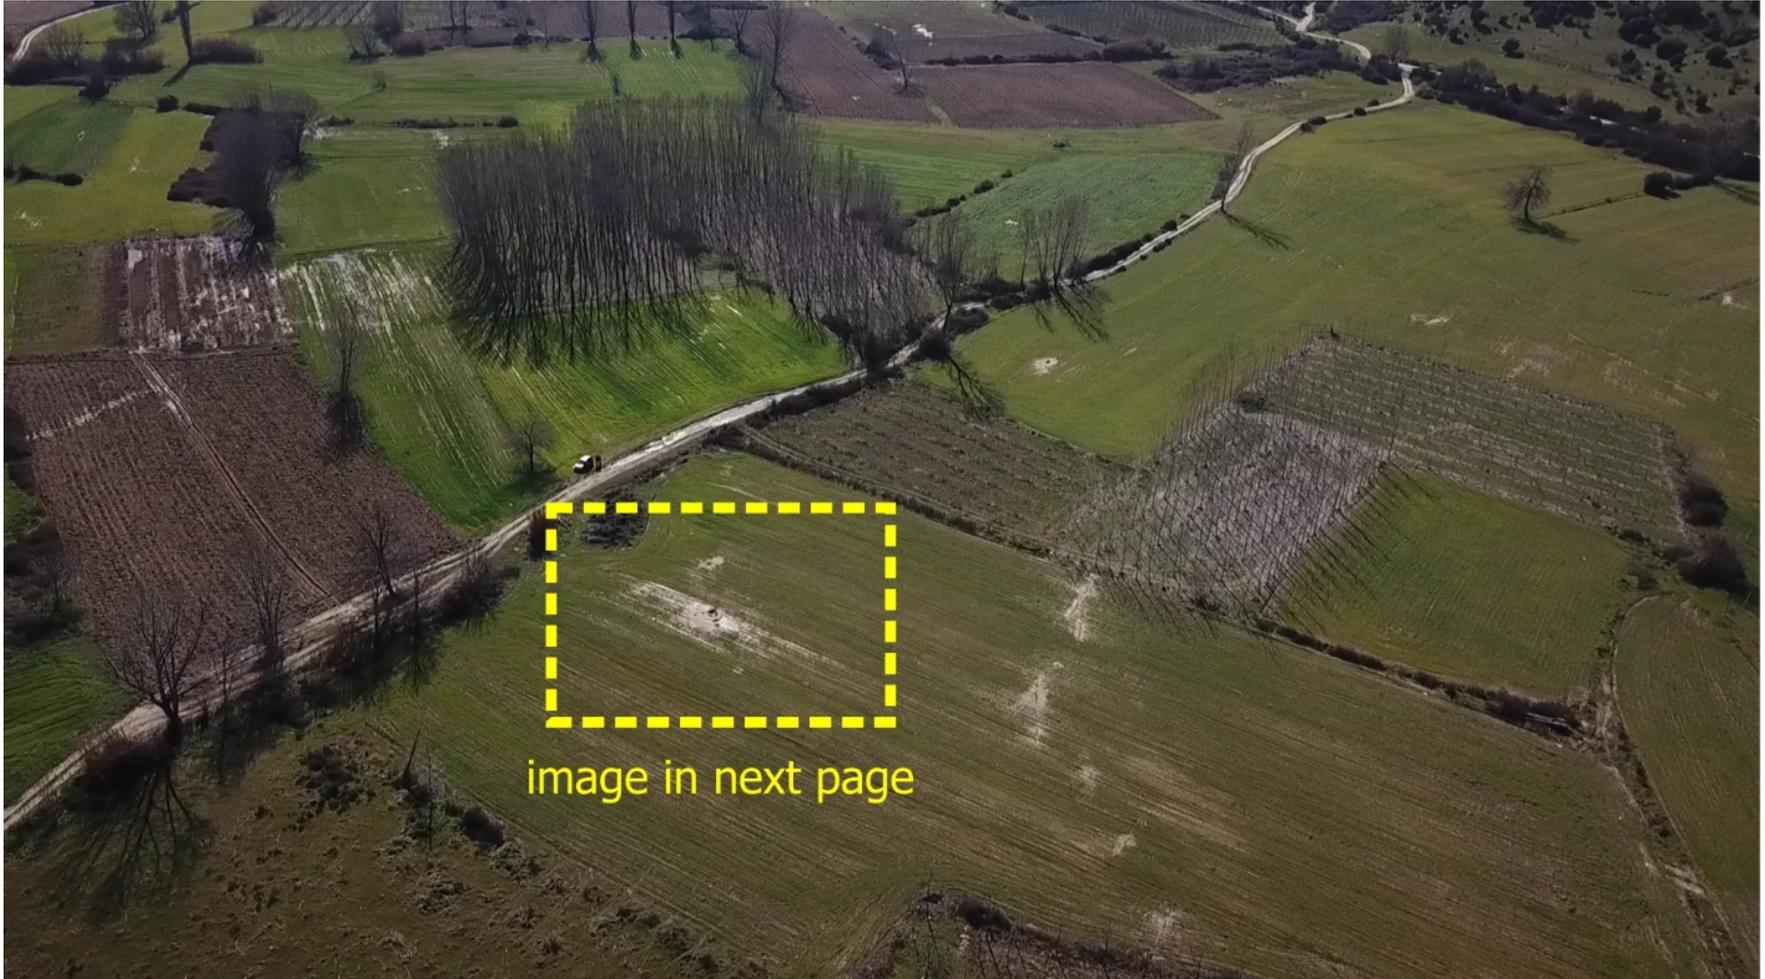
Extended liquefaction phenomena in the area located southeast of Vlachogianni village, east of the Titarissios River. The grey spots in the green fields correspond to ejected liquefied material.

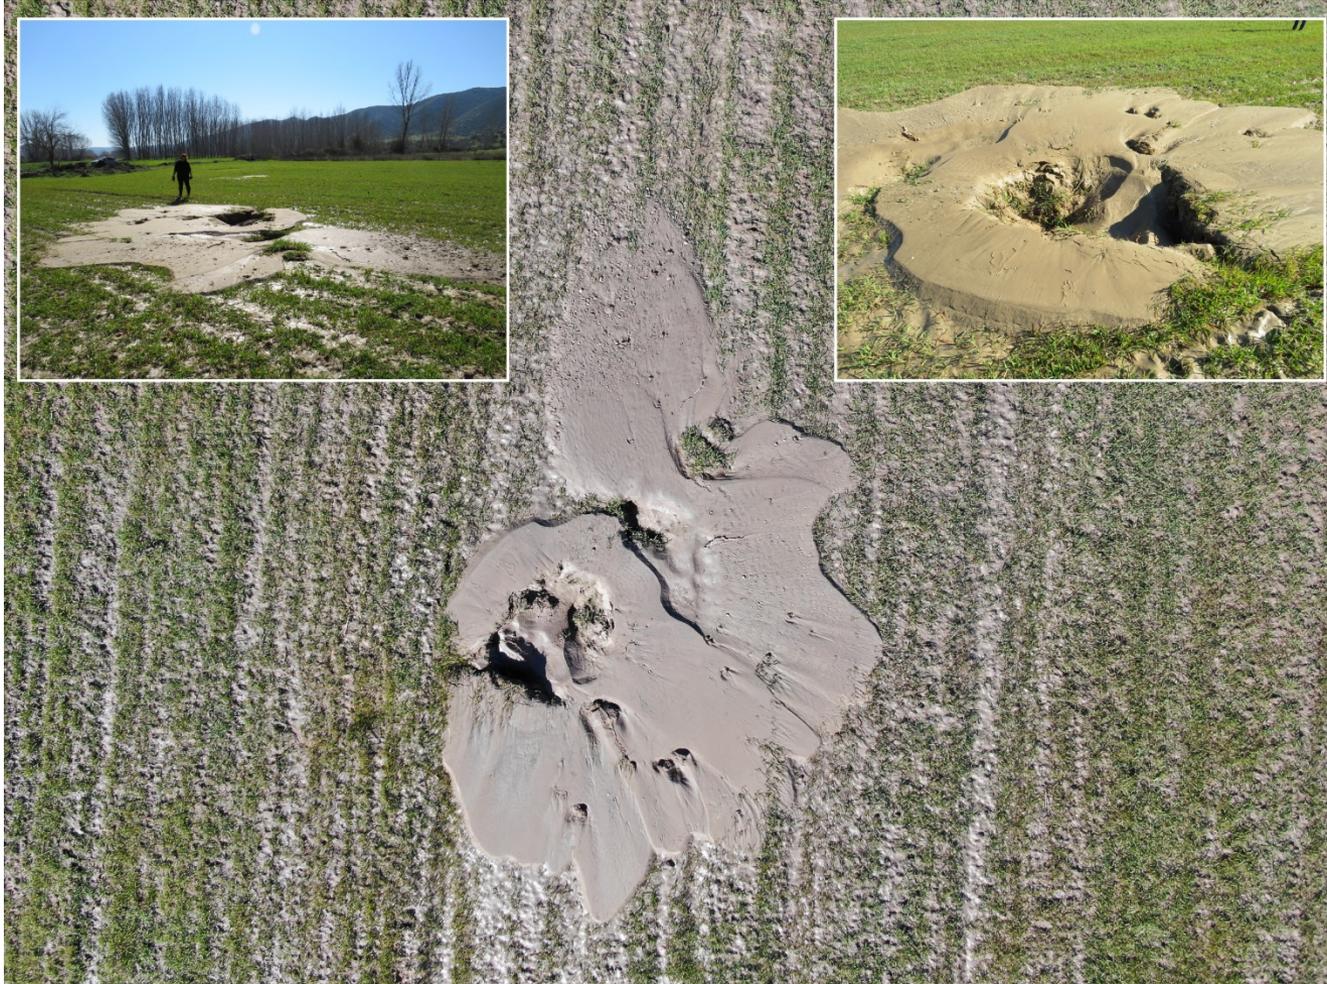
Individual sand boils in a field located southeast of Vlachogianni village, east of the Titarissios River

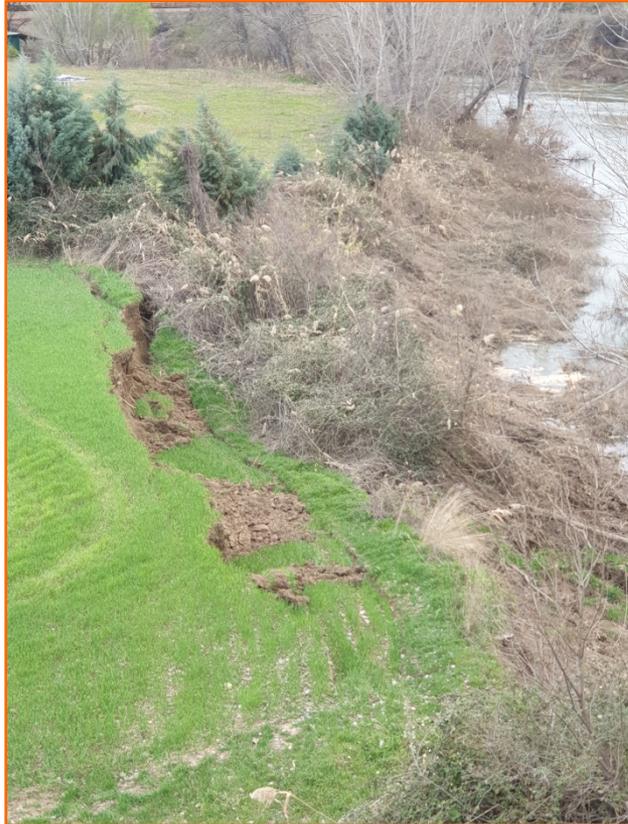
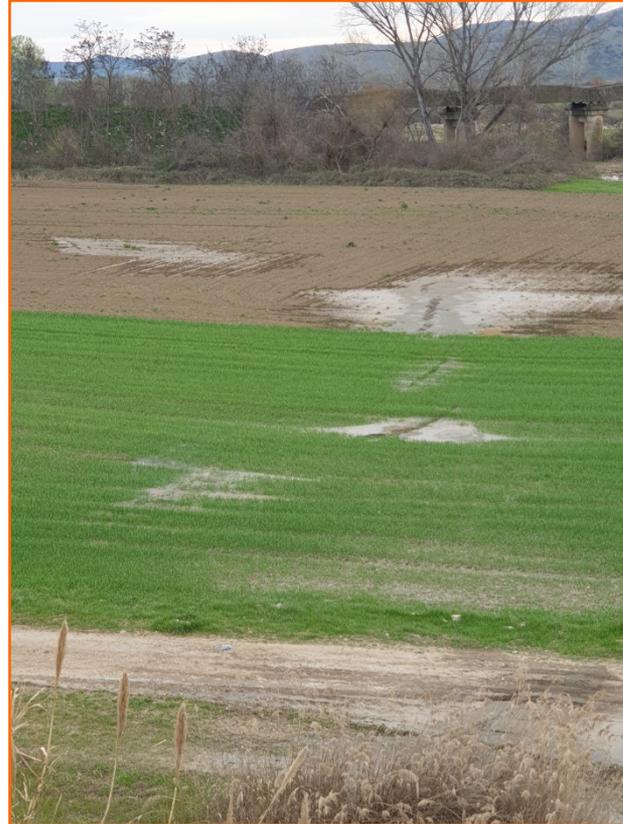
(**Left**) Lateral spreading along the Pineios River banks, (**middle**) liquefaction phenomena in the fields close to Pineios River and (**right**) ground cracks arranged parallel to the Pineios River. It is significant to note that these secondary earthquake environmental effects were observed close to the bridge of Pineios River located close to the Koutsochero village. The bridge suffered cracks and damage due to seismic pounding between bridge segments.

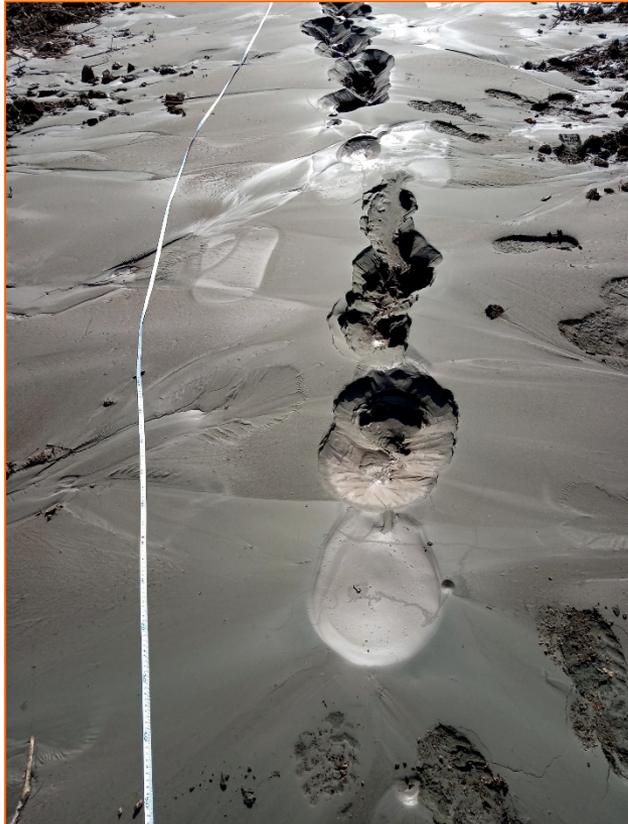
Liquefaction phenomena were also generated in the southwestern part of the affected area. More specifically, in the Pineios River bed from Pineiada to Farkadona. They comprise sand boils along ground cracks with length up to 60 meters. They are attributed to the lithology of the river deposits, the shallow water level in the river bed and to the intense earthquake ground motion.

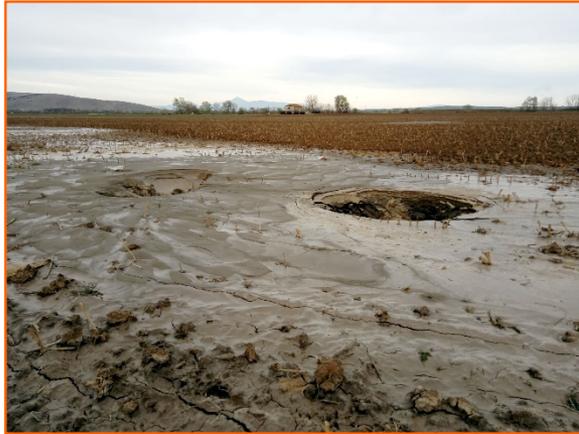
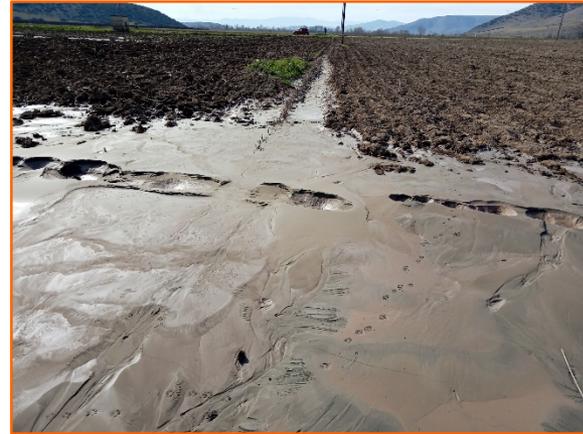
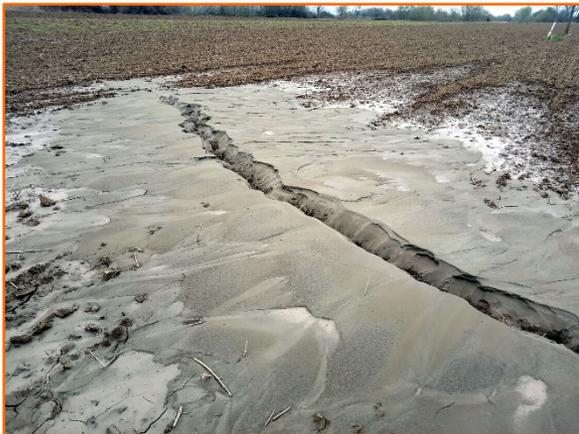
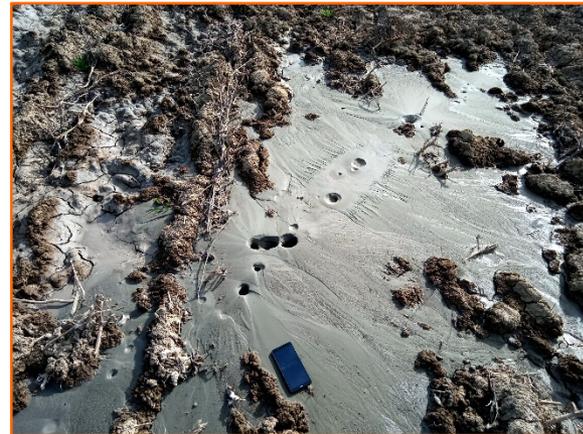
## SECONDARY EARTHQUAKE ENVIRONMENTAL EFFECTS LIQUEFACTION BETWEEN PINIADA AND FARKADONA

More typical examples of the generated liquefaction phenomena in the southwestern part of the affected area. Large craters were formed, from which the liquefied material has been ejected and partially covered the adjacent field. The extend of the liquefied material indicate the intensity of the earthquake ground motion.

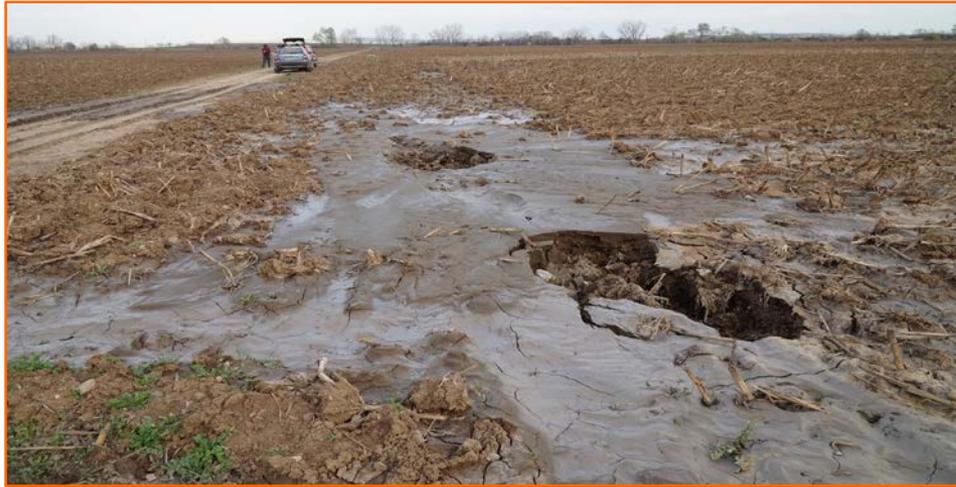
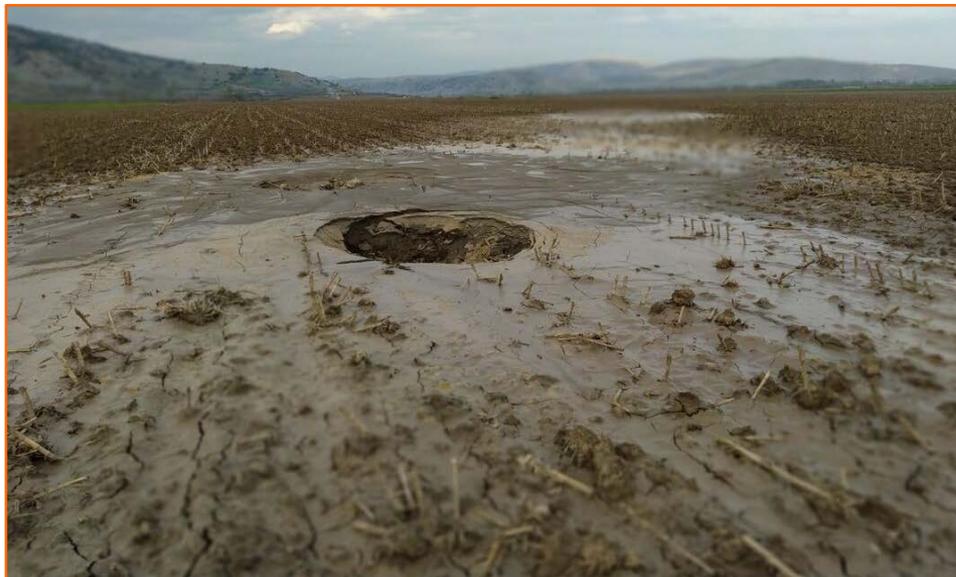
## SECONDARY EARTHQUAKE ENVIRONMENTAL EFFECTS LIQUEFACTION BETWEEN PINEIADA AND FARKADONA

Dozens of soil liquefaction occurrences, such as sand craters and flows were mapped in areas adjacent to Pineios and Titarissios Rivers. These figures of sand flow and craters are impressive examples from the liquefied area located southeast of Pineiada village.

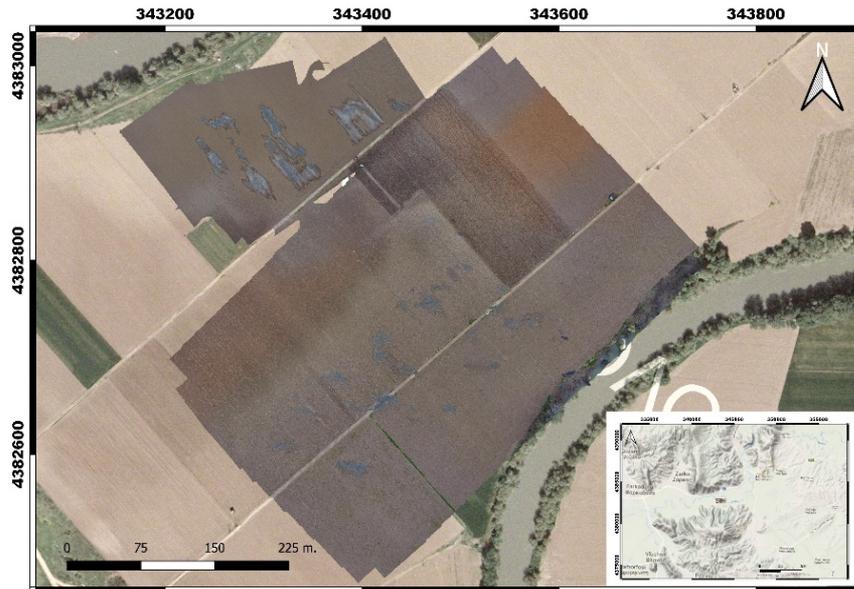
▲ Orthorectified image of the liquefied areas (gray spots). Images from a series of high flying UAV campaigns have been combined with orthophotos from the Cadastral project of Greece.

The liquefaction phenomena were mapped in great detail with UAVs. Comparison with current and historical satellite images, show that in the area of Pinios river the liquefaction is clearly associated

with older abandoned meanders of the river, indicating a differentiated composition, more susceptible to liquefaction.

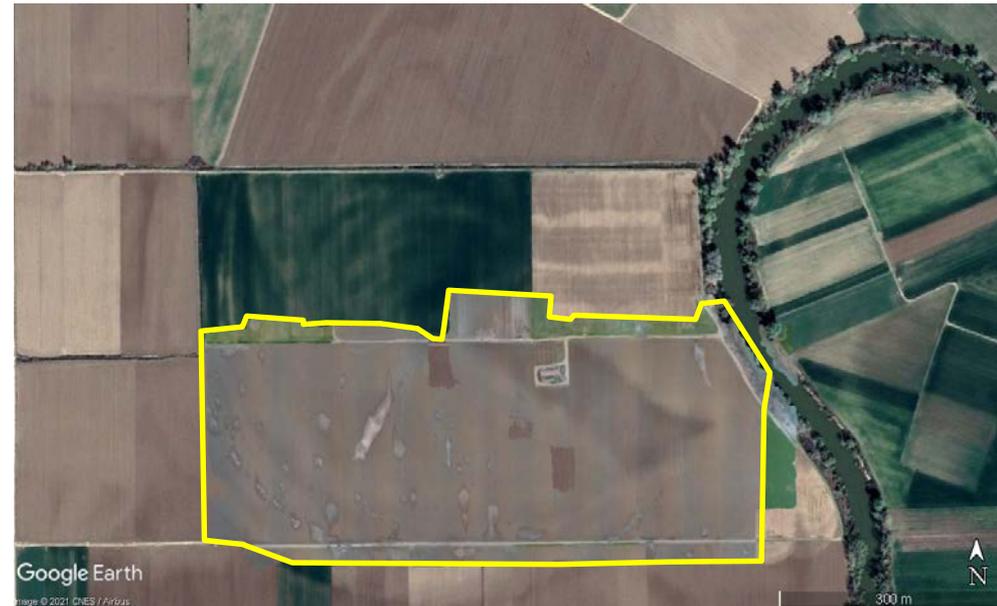
▲ Comparison with current and historical satellite images, show that in the area of Pineios river the liquefaction is clearly associated with older abandoned meanders of the river, indicating a differentiated composition, more susceptible to liquefaction

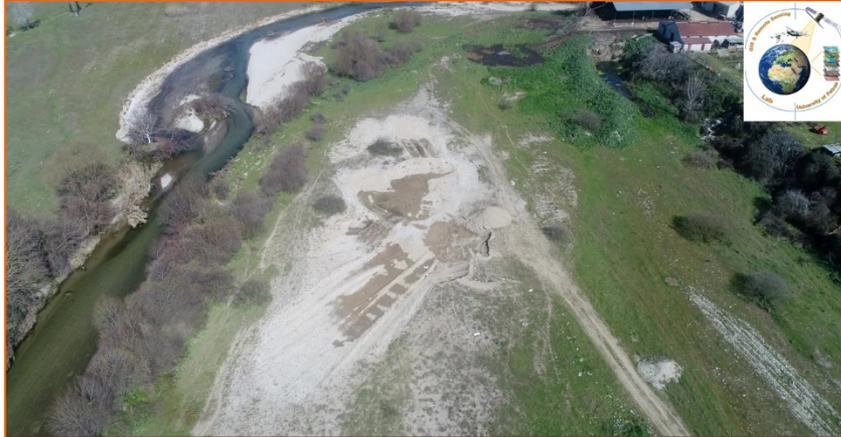
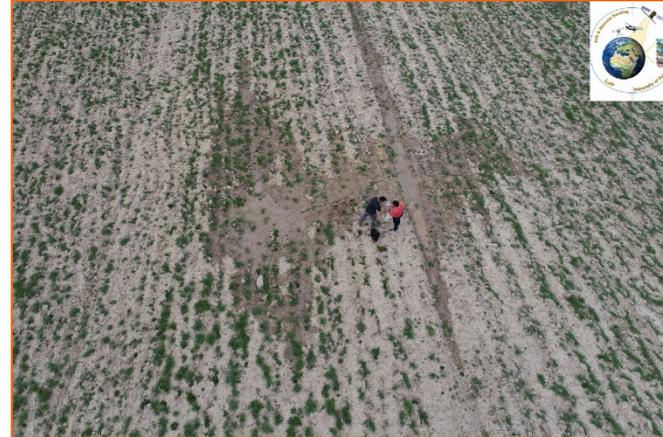
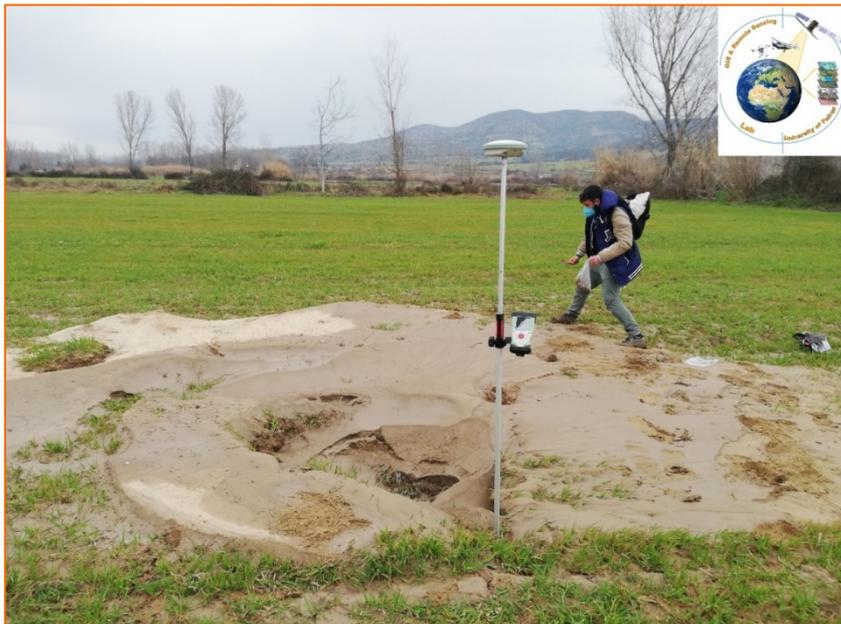
## SECONDARY EARTHQUAKE ENVIRONMENTAL EFFECTS MAPPING OF LIQUEFACTION WITH UAV AND RTK GNSS RECEIVERS

The scientific team of the University of Patras (Koukouvelas, Nikolakopoulos, Kyriou, Apostolopoulos, Zygouri, Verroios, Belesis, Tsentzos) mapped with UAVs and RTK GNSS receivers several ground cracks and liquefaction phenomena in the broader area of Damasi, Mesochori and Vlachogianni.

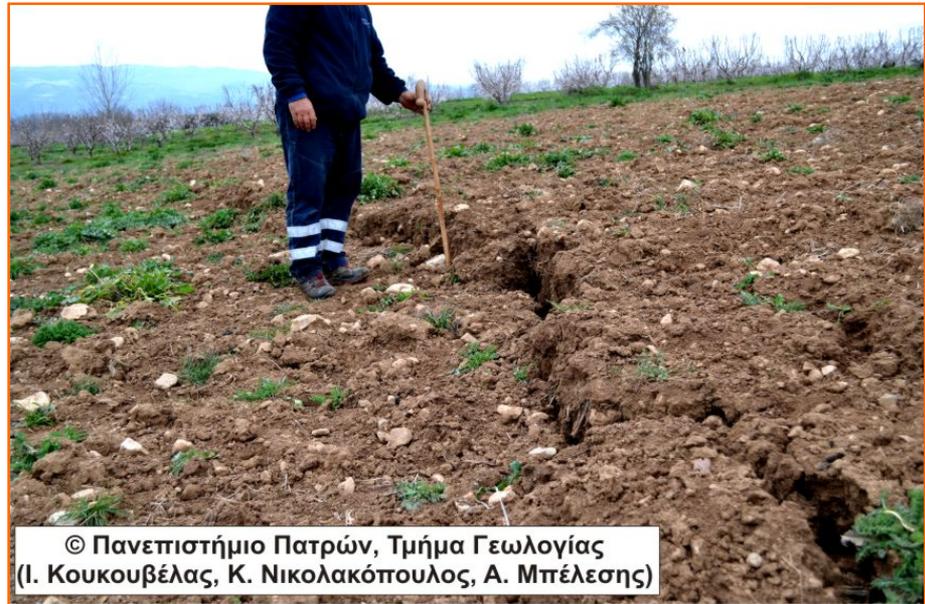
▲ Surface trace of the co-seismic rupture in Vlachogianni area. The photo shows part of the compound fault scarp and the offset as well. The photo is looking west. Surface offset on the fault trace is over than 25 cm.
