# Newsletter of **Environmental, Disaster, and Crises Management Strategies**

Issue No.22 | March 2021

## The early March 2021 Thessaly earthquake sequence

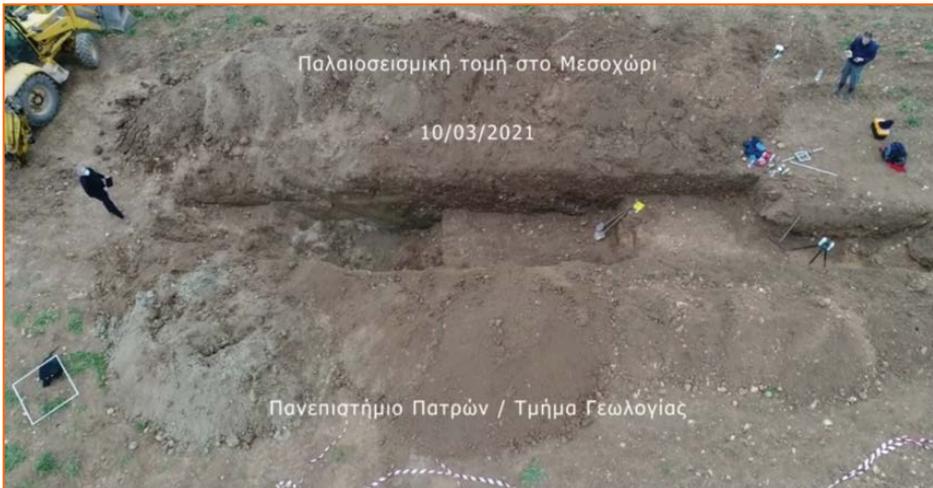
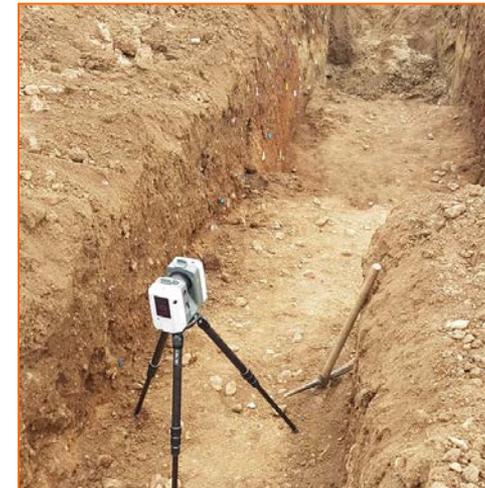
Palaeoseismological trench from above. Drone footage of the California style trench at Meschori area and LiDAR mapping of the excavated trench

The scientific team of the University of Patras mapped several places showing clear tectonic expression, although the intense geographic and cultural modifications due to human activities disturbed the near surface stratigraphy. As a consequence, they found only one favorable site for trenching near the Titarissios River. Paleoseismological trenching in Greece has proved to be a powerful tool in recognizing strong past earthquakes. We employed two single-slot “California style” trenches and followed standard

trenching methods (left figure below). The main trench was 10 m long and 2.0 m wide, while its maximum depth was almost 2.5 m. The single-slot trench was excavated across a 1 m high fault scarp. The trench walls were cleaned and mapped manually and with LiDAR (right figure below), using a 0.5 x 1m reference grid of non-stretch string. Photo mosaics of the exposure were developed using image processing software. The surface traces offset matches directly the subsurface exposure within the trench.

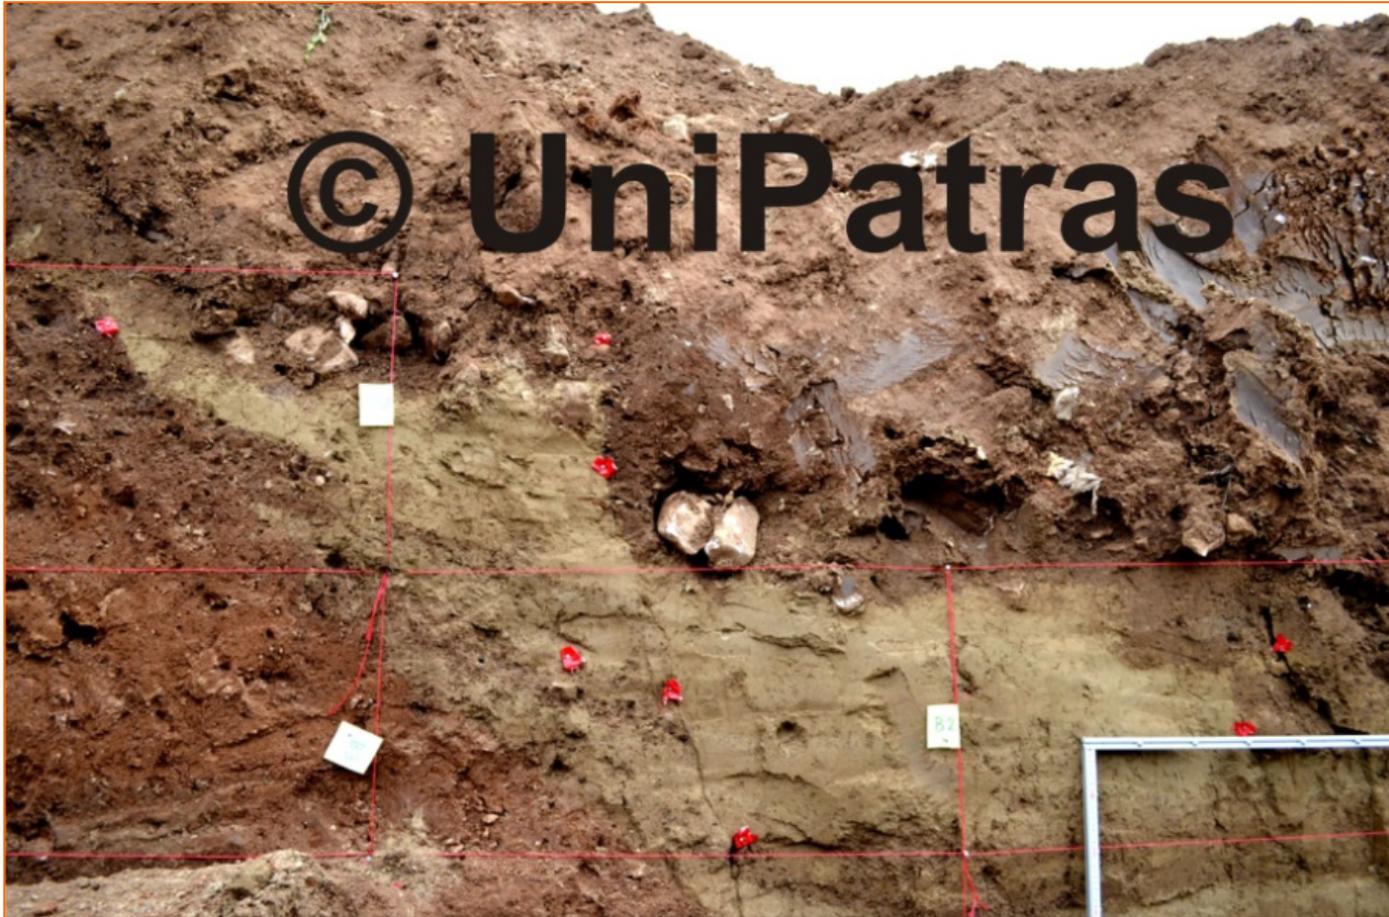
Detail of the fault in the palaeoseismological trench

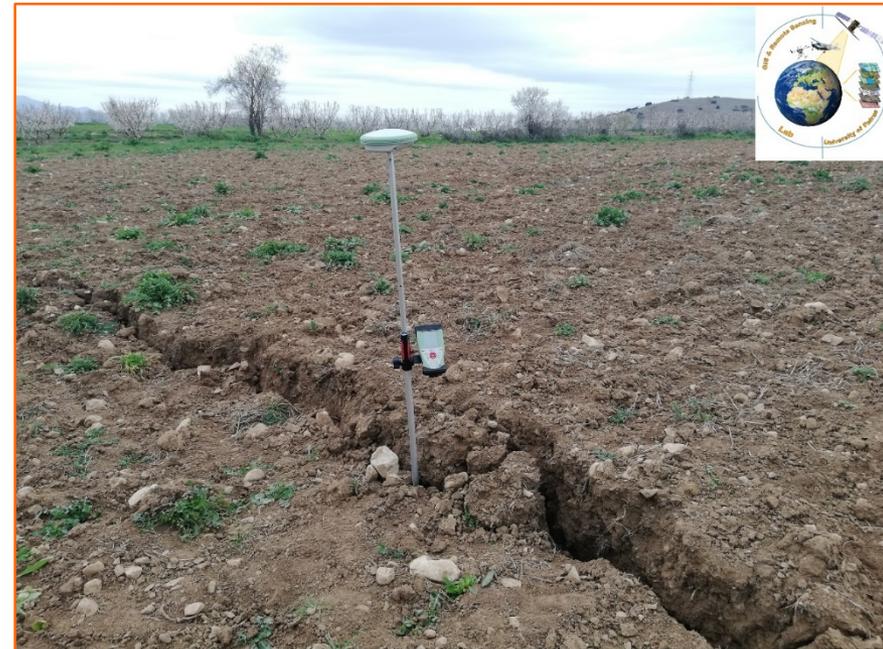
The fault trace was mapped by  
RTK GNSS receiver

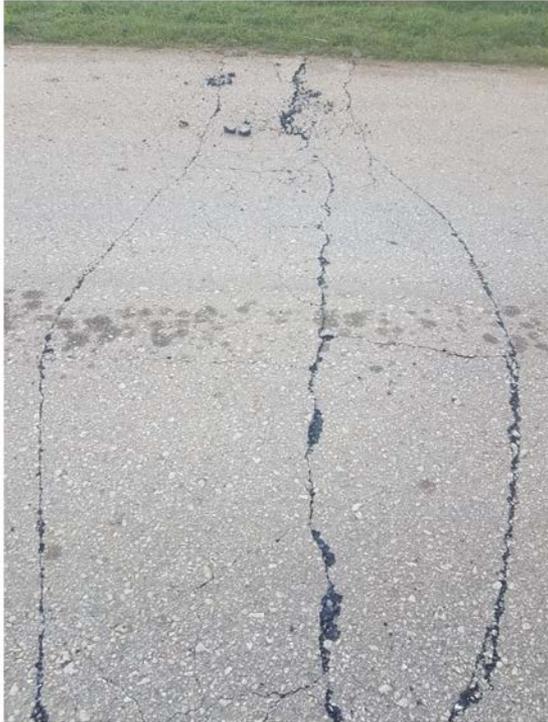
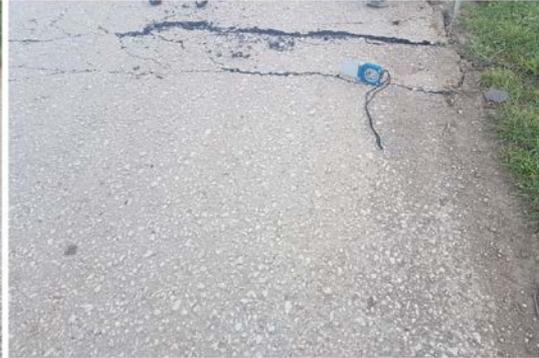
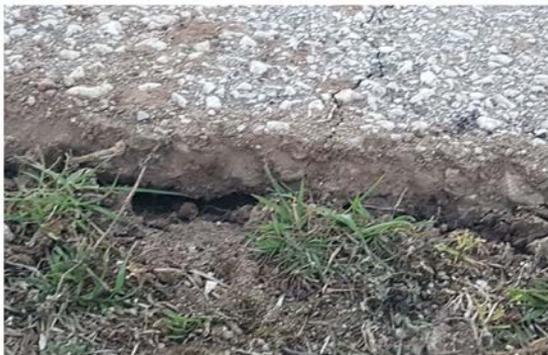
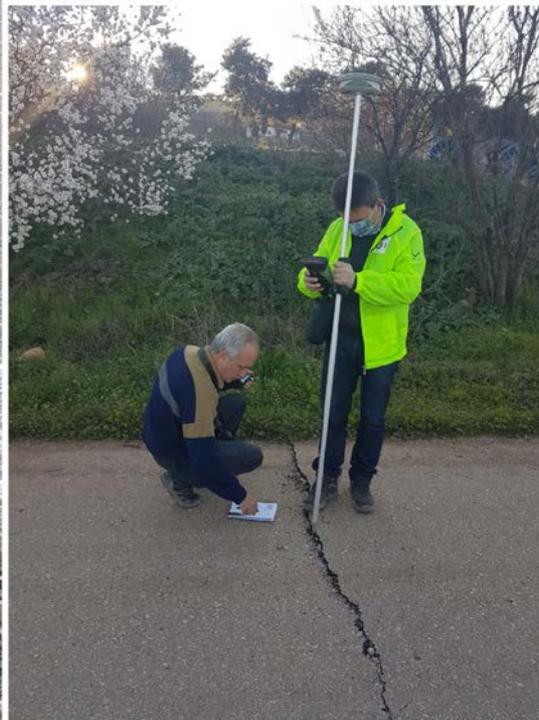
## PRIMARY EARTHQUAKE ENVIRONMENTAL EFFECTS IMPACT ON THE ROAD

Mapping extensive ground cracks generated by the March 3, 2021, Mw=6.3 earthquake near Damasi village

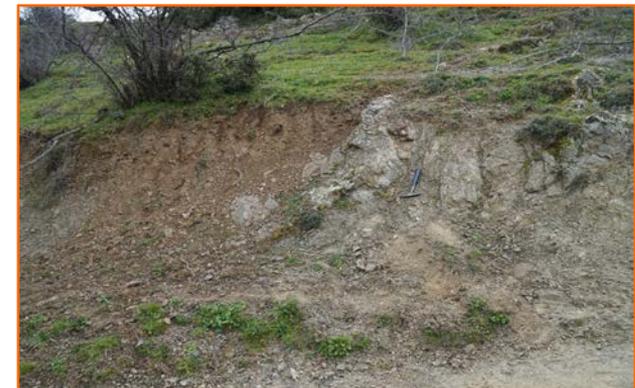
Coseismic surface cracks in the soil cover, following the inferred strike and location of the causative fault zone in the bedrock

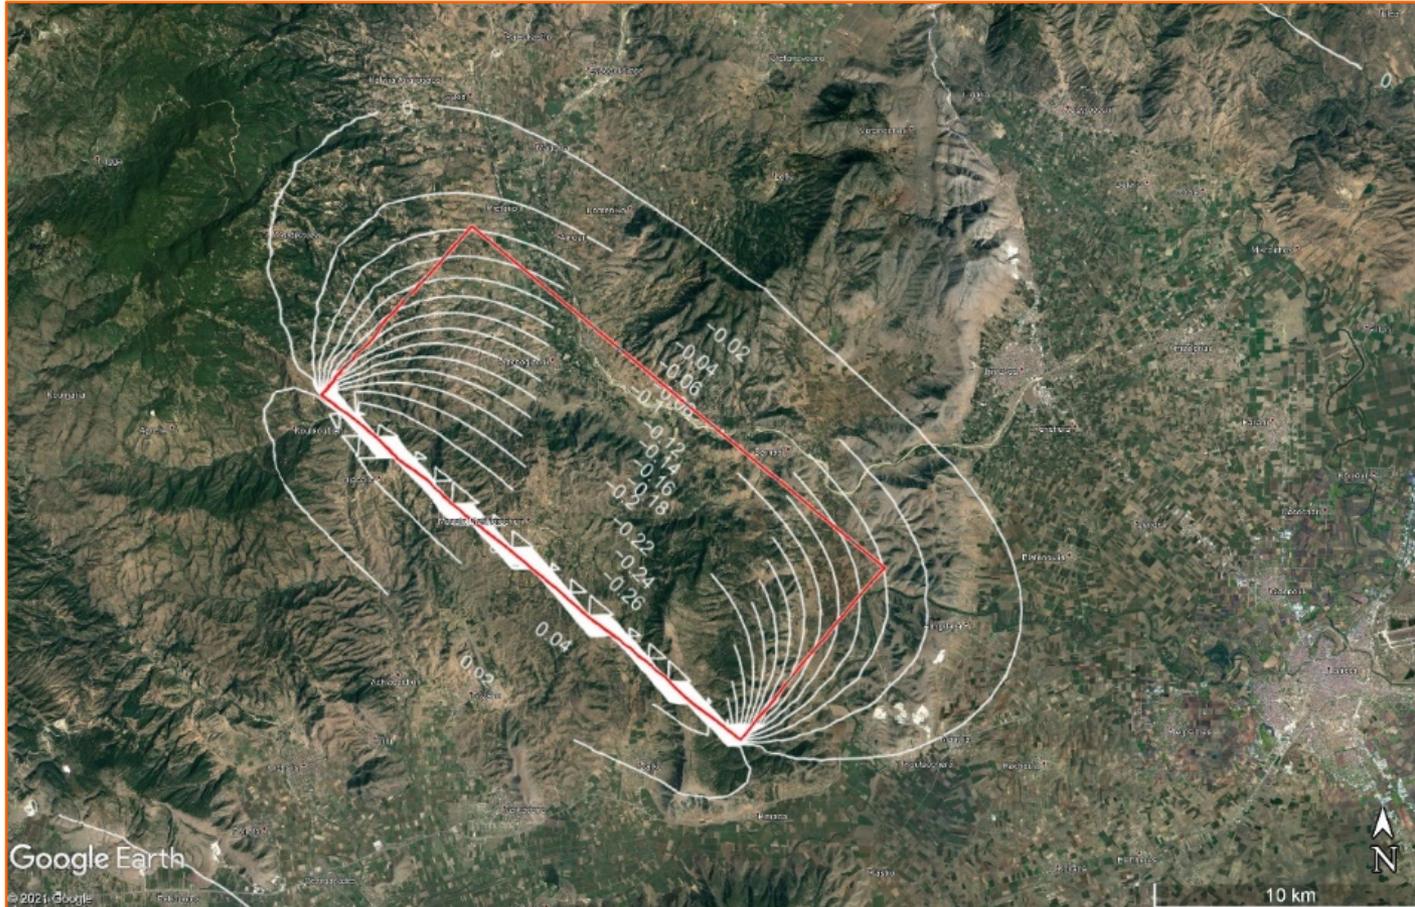
A preliminary model of the seismic source is showing vertical displacement on the ground

The seismic source is also used to model the vertical displacement on the ground after using the Okada formulae. The maximum calculated vertical displacement is 2.93 cm. Both Coulomb and Okada calculations were performed with the Coulomb v3.3 application (Toda et al., 2005; Lin & Stein, 2004).

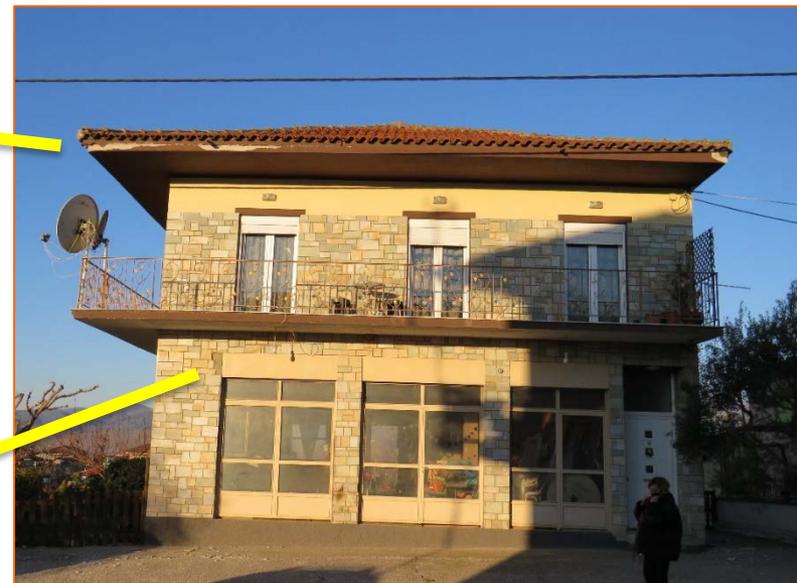
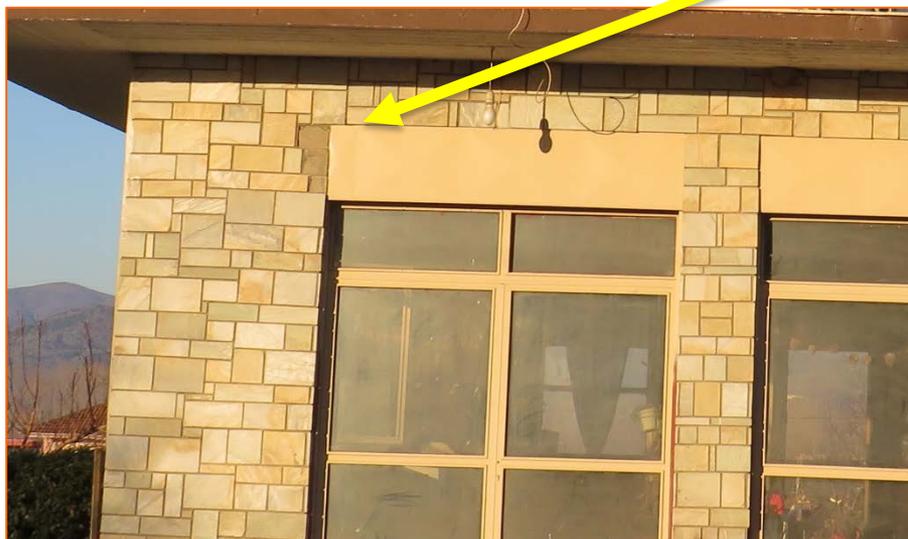
## NON-STRUCTURAL DAMAGE TO REINFORCED CONCRETE BUILDINGS MESOCHORI VILLAGE

The majority of the reinforced concrete (RC) buildings of the earthquake affected area remained intact by the earthquake. Slight damage was observed to non-structural elements of the buildings. Typical example of slight damage are the detachment and fall of cornices, roof tiles and exterior wall cladding composed of different materials. We observed that the free standing or lightly anchored objects in stiffer structures suffered more damage compared to those standing in more flexible ones.

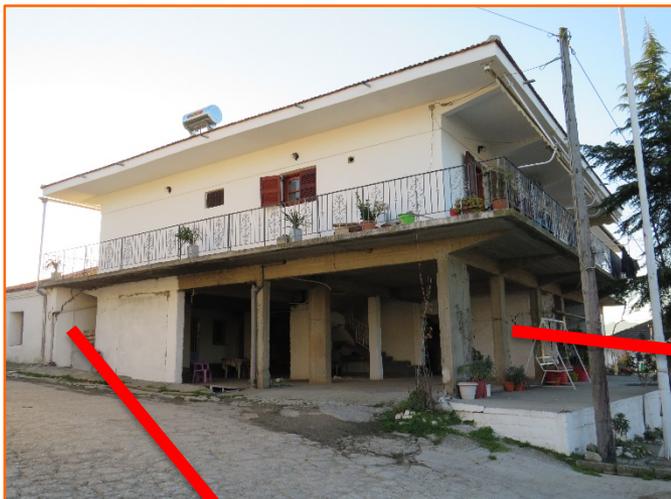
## NON-STRUCTURAL DAMAGE TO RC BUILDINGS MESOCHORI VILLAGE

▲ Non-structural damage to building with RC frame and infill walls. It comprised detachment of plaster from the infill walls and extensive cracking of brick walls. The upper floor remained intact by the earthquake. The much softer ground floor is functioning as a kind of base isolator, absorbing thus, in its body, the seismic motion. The observed damage of the few partition brick walls is a physical consequence.

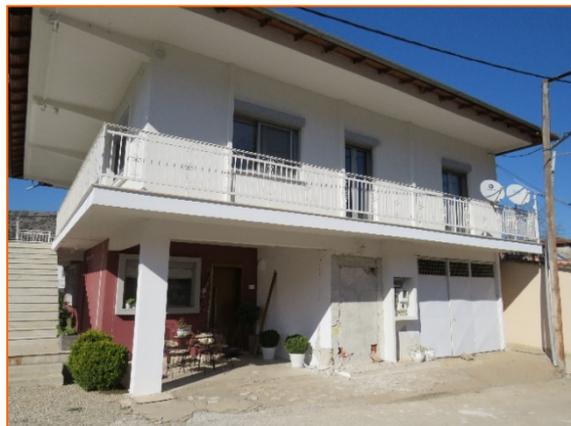
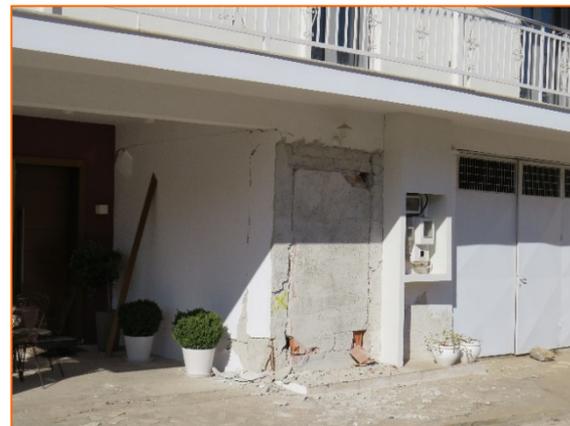
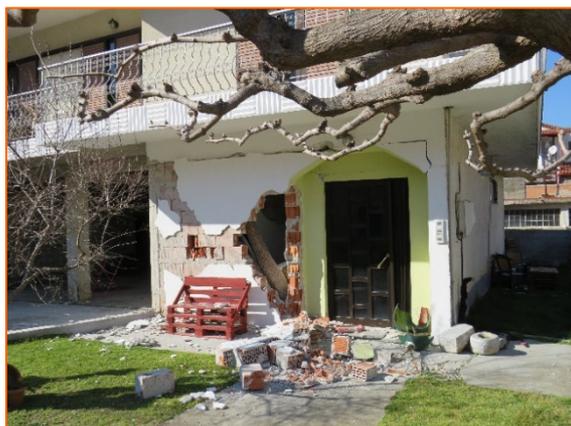
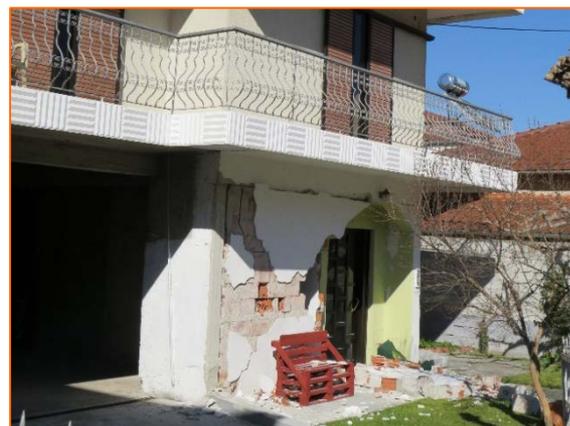
## STRUCTURAL DAMAGE TO RC BUILDINGS DAMASI VILLAGE

Non-structural damage to R/C buildings were limited. Some cases were observed in the most affected villages, like Damasi village. Non-structural damage comprise detachment of the infill walls from the surrounding RC frame and partial collapse of the infill walls. Compression damage in the lower parts of the columns were also observed in RC building of the same village, an indication of the presence of strong vertical component of the seismic motion – a basic characteristic dominating in epicentral regions.

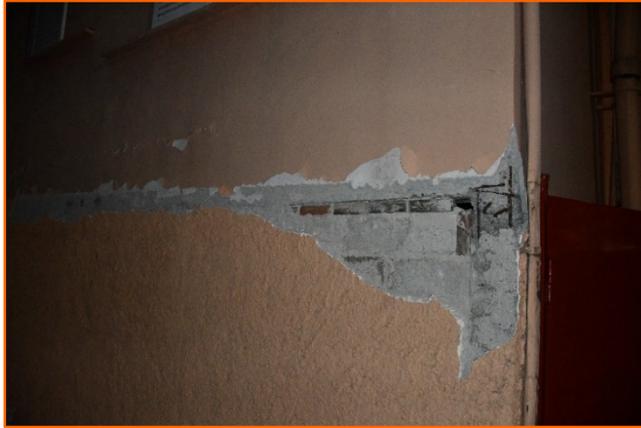
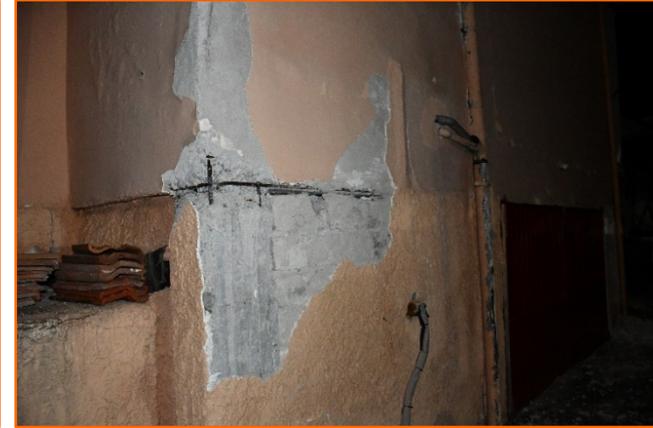
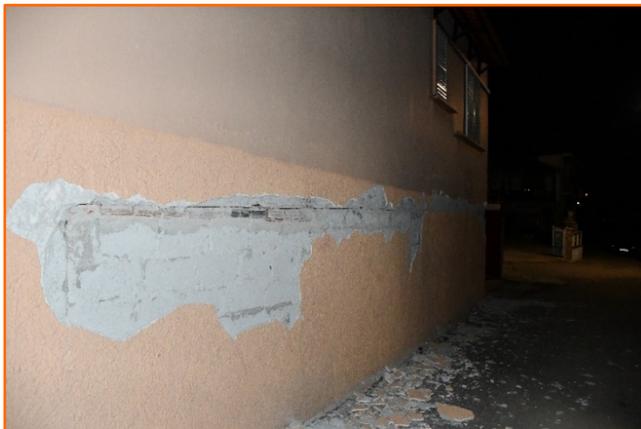
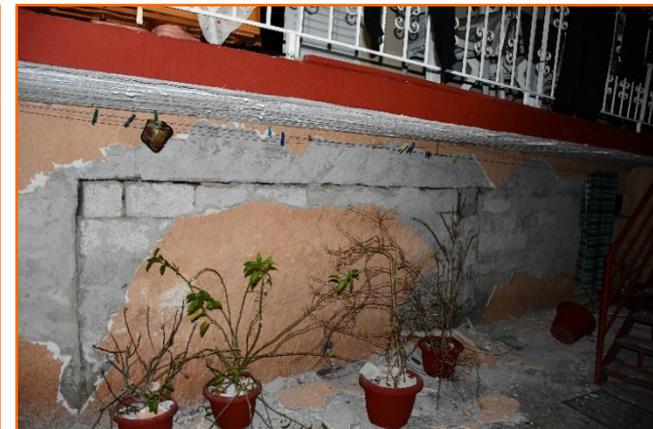
## STRUCTURAL DAMAGE TO RC BUILDINGS DAMASI VILLAGE

Damage to an RC building in Damasi village. Non-structural damage comprises detachment and fall of large pieces of plaster along the connection of the infill walls with the surrounding RC frame, detachment of the infill wall from the frame. Structural damage includes loss of concrete in the upper body of the RC column, exposure and slight buckling of reinforcement bars. The horizontal quite large cracks and the failure of the plaster at the ceiling of the cantilever constitute indication of the effect of strong vertical seismic component.

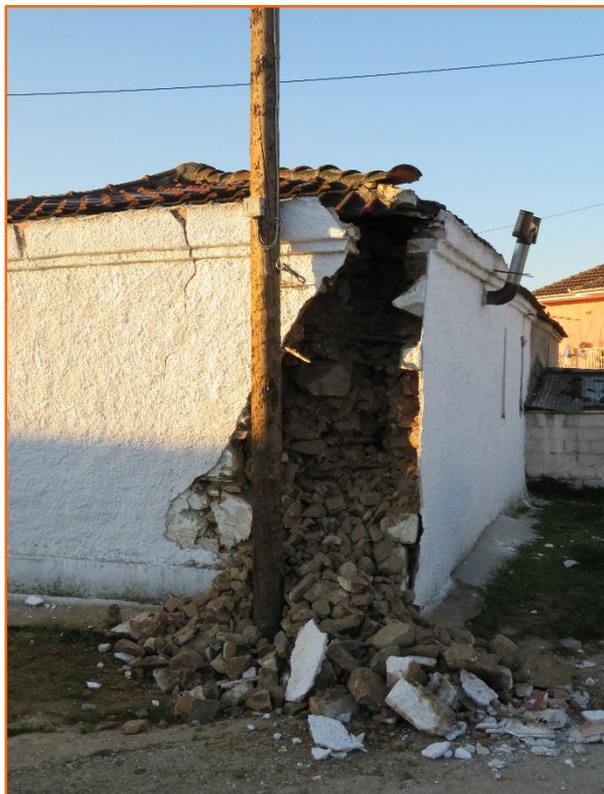
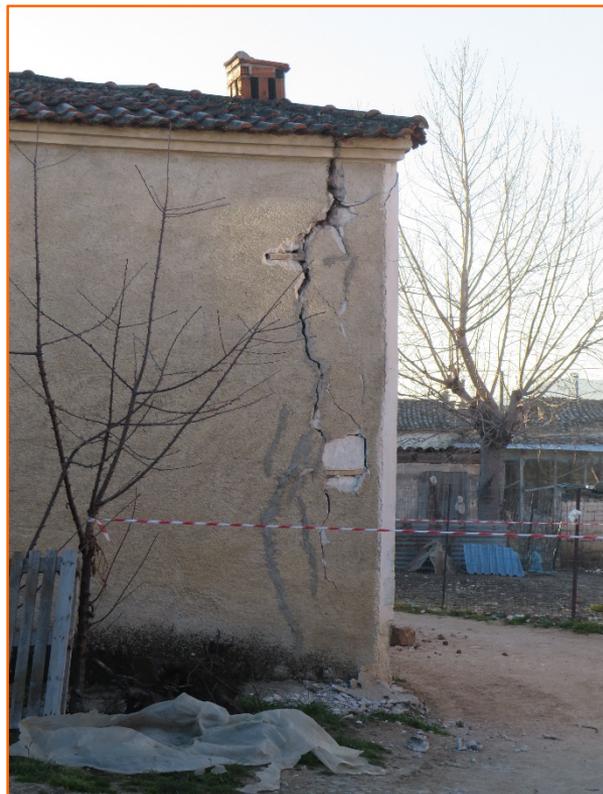
## DAMAGE TO BUILDINGS WITH LOAD-BEARING MASONRY WALLS VERTICAL CRACKS

Severe vertical cracks and gaps were frequently formed and propagated along the height of the bearing wall intersections. This damage is attributed to the absence of horizontal banding means (beams, tie rods), which could provide structural integrity and the adequate connections between the bearing walls at the wall intersections and between the bearing walls and the roof. It is significant to note that the chimneys are standing intact, which is also an indication of the dominating vertical component of the seismic motion.

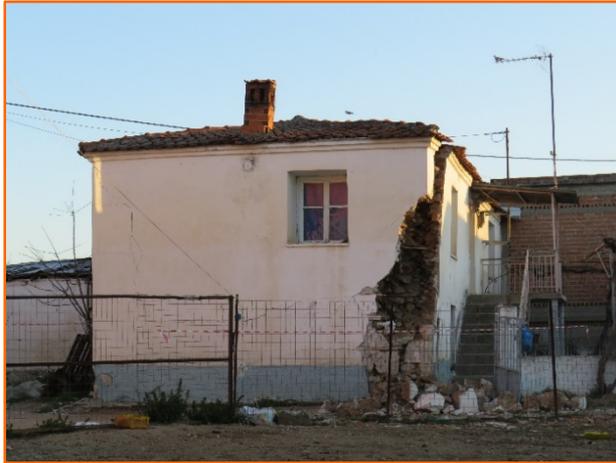
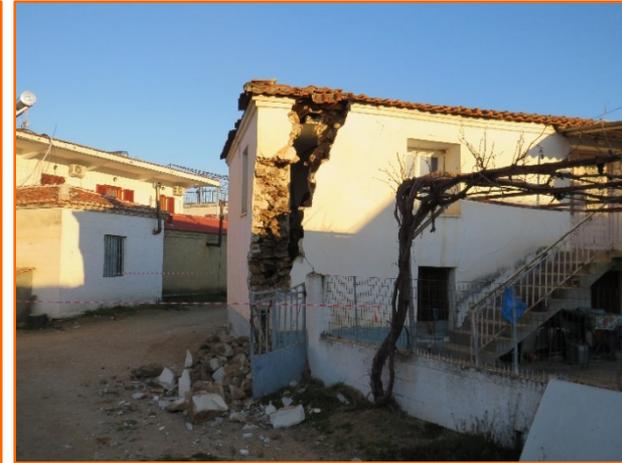
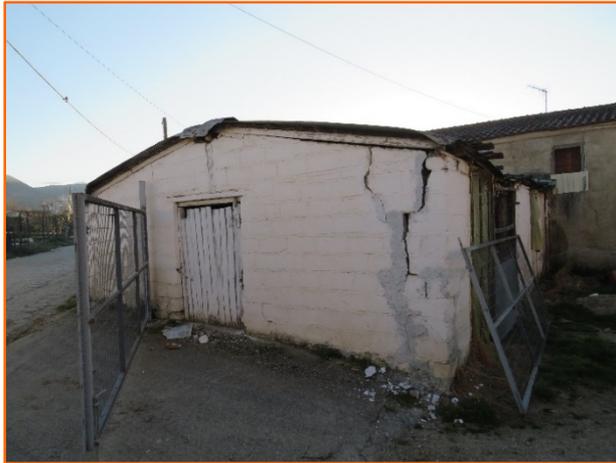
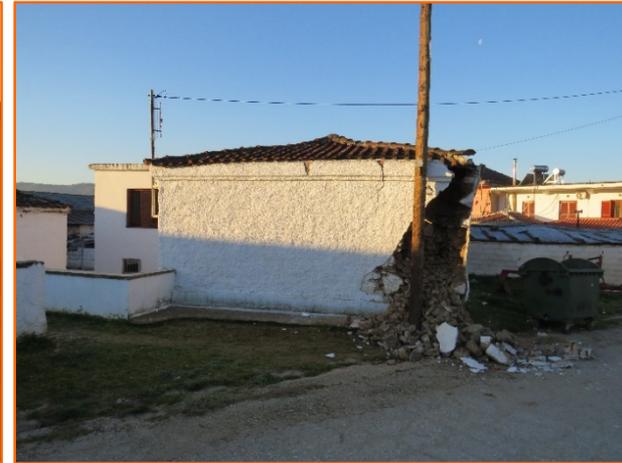
## DAMAGE TO MASONRY BUILDINGS WITH LOAD-BEARING WALLS VERTICAL CRACKS AT WALL INTERSECTIONS

Due to the lack of the aforementioned horizontal band beams, each wall acts individually in in-plane as well as out-of-plane directions under the earthquake loads resulting in vertical cracks at the wall intersections. With these more general views, one could observe the complete lack of diagonal cracks in the masonries.

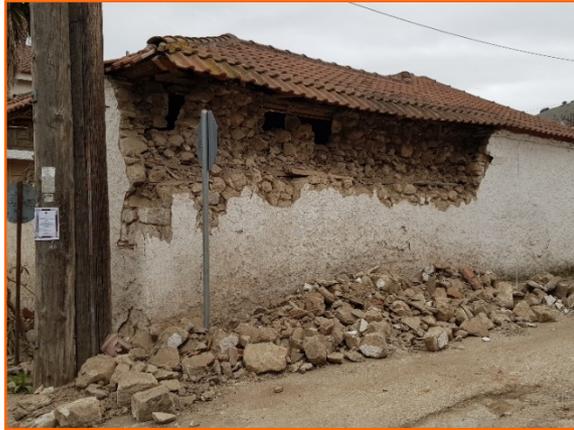
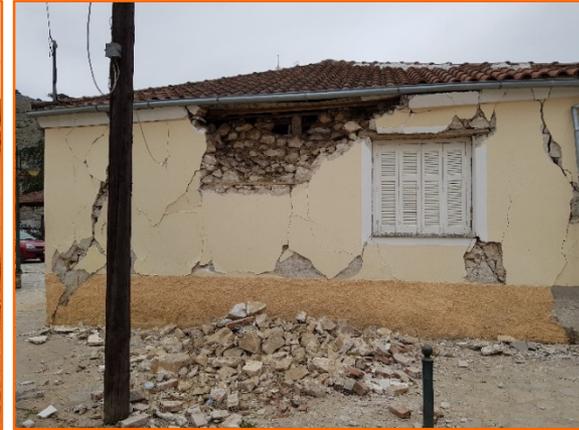
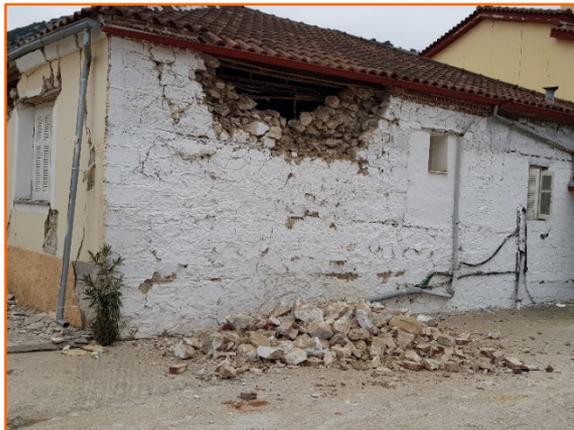
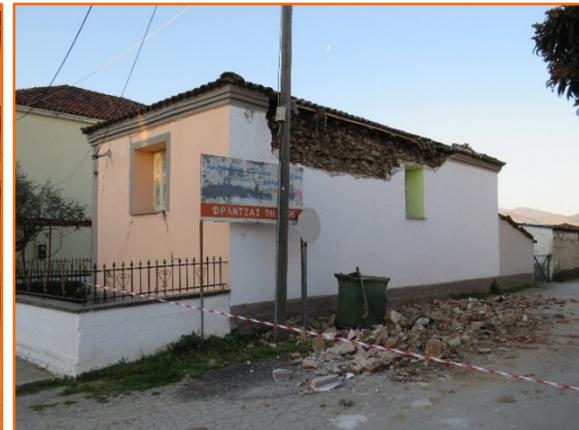
## DAMAGE TO MASONRY BUILDINGS WITH LOAD-BEARING WALLS DAMAGE DUE TO FLEXIBLE ROOF-WALL INTERACTION

Failures of the upper part of the walls were also attributed to the interaction of roof structure and perimeter walls. This type of damage did not reach collapse condition, but the masonry buildings were unusable during the emergency period. It is also observed that the two layers of the masonry are functioning independently, without connection between them.

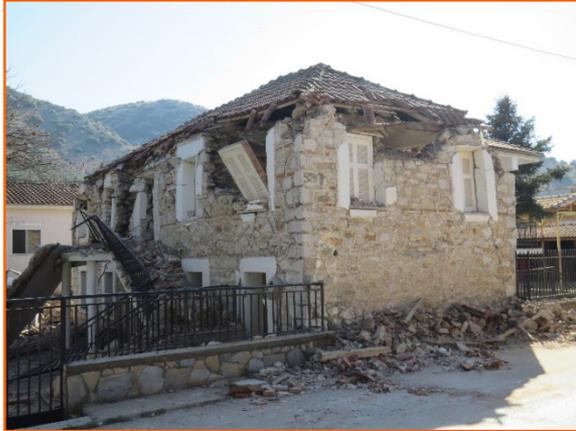
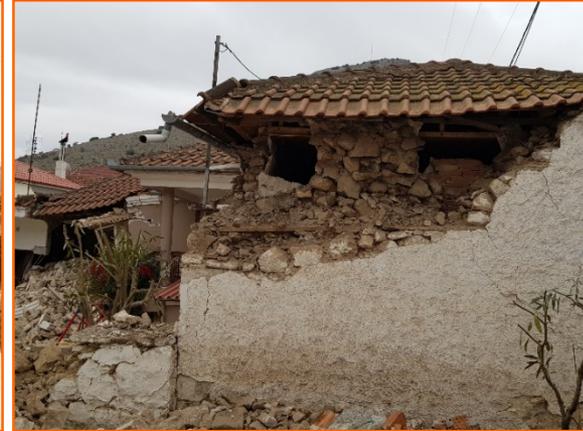
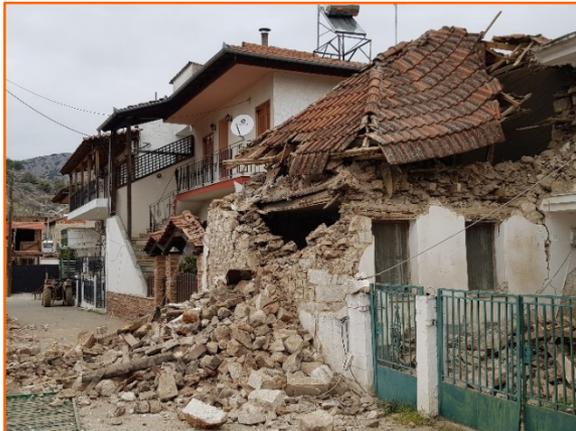
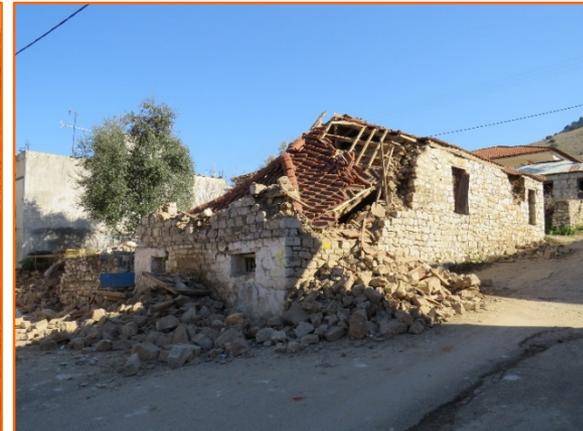
## DAMAGE TO MASONRY BUILDINGS WITH LOAD-BEARING WALLS DAMAGE DUE TO FLEXIBLE ROOF-WALL INTERACTION

Heavier damage including collapse attributed to interaction of roof structure and perimeter walls. The observed damage are almost symmetrical distributed around the plan of the structure, as shown for example in the top left image.

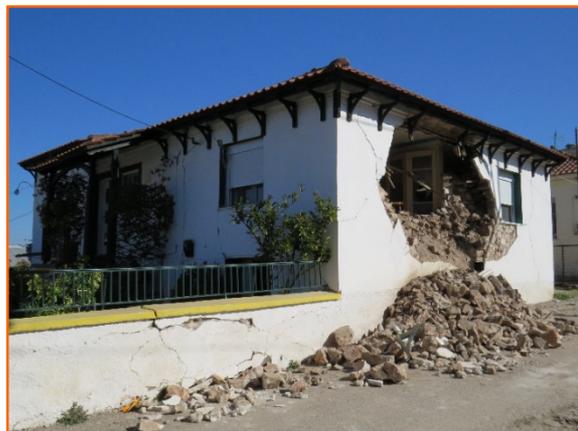
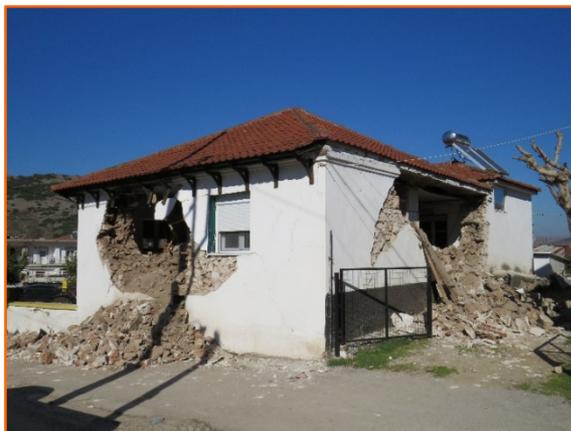
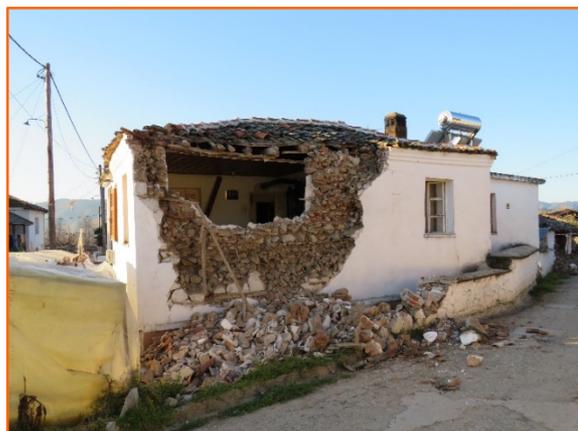
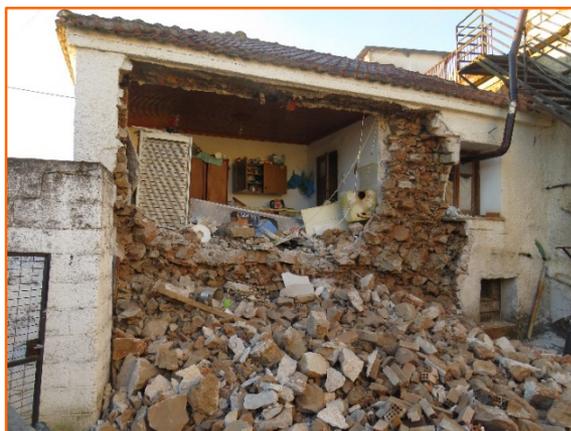
## DAMAGE TO MASONRY BUILDINGS WITH LOAD-BEARING WALLS DAMAGE DUE TO FLEXIBLE ROOF-WALL INTERACTION

One may well observe the similarity of the incurred damage (at the central part of the walls) independently of the type and the age of the structure. This similarity is due to the same structural scheme and flexibility of almost all roofs. This flexibility is along their vertical axis and is proportional to the ratio of the opening of the roof over the crest height. This ratio is quite large, and it is rather sensitive to vertical vibrations.

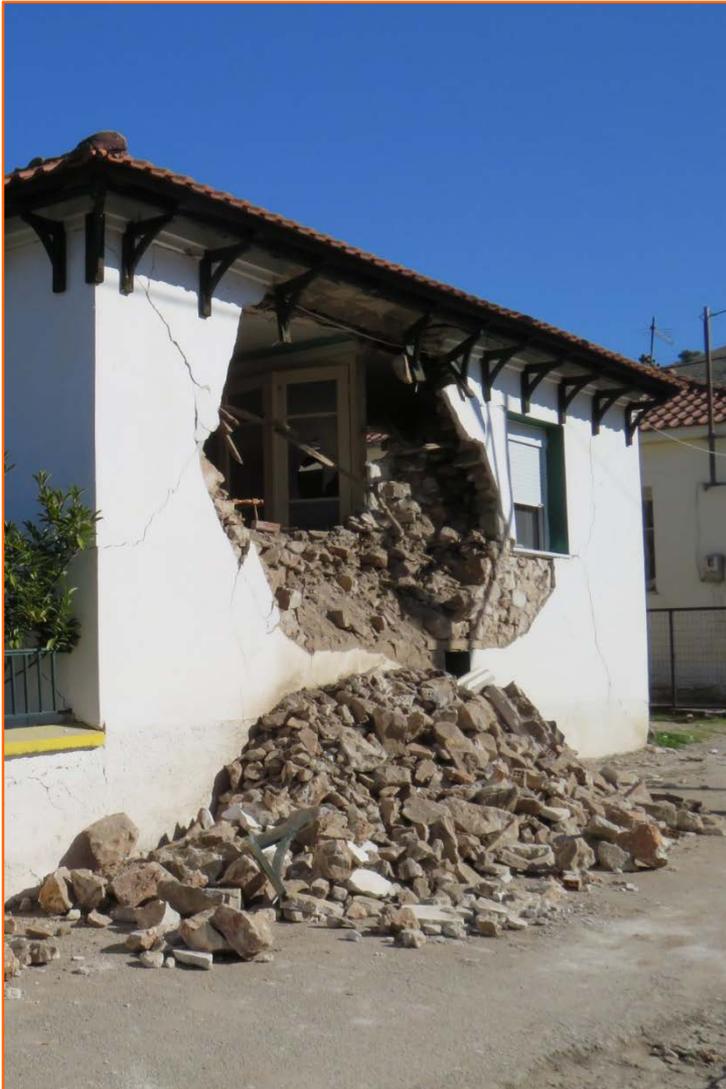
## **DAMAGE TO MASONRY BUILDINGS WITH LOAD-BEARING WALLS DAMAGE DUE TO FLEXIBLE ROOF-WALL INTERACTION**

The incurred damage present almost the same manner independently of the mechanical characteristics of the underlying structures. This type of damage (at the center of the perimeter walls), may be attributed to:

- high flexibility of the roof due to rather large ratio of roof opening over crest height,
- the strong seismic vertical component that is exciting the roof, which, in turn, pushes the walls outwards.

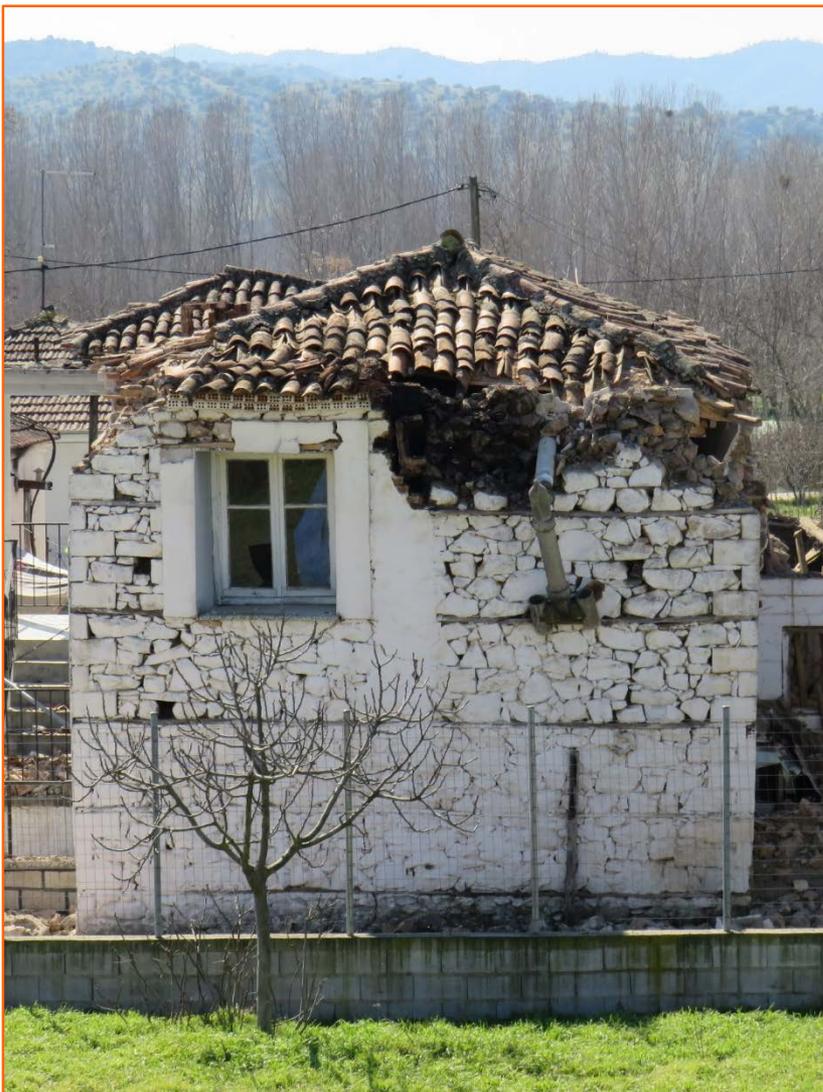
## **DAMAGE TO MASONRY BUILDINGS WITH LOAD-BEARING WALLS DAMAGE DUE TO POOR MORTARS**

The old unreinforced masonry buildings consist of poor quality mortar. Those types of poor quality mortar are rich in clay, which is highly aquatic. Due to the entry of the moisture into the mass of the wall from the ground and / or from the roof, the friction between mortar and stone blocks, which is beneficial for the strength and stability of the wall, is dramatically reduced until annulated. Actually, the moisture convert clay from a bonding to a slippery material.

◀ In Mesochori village

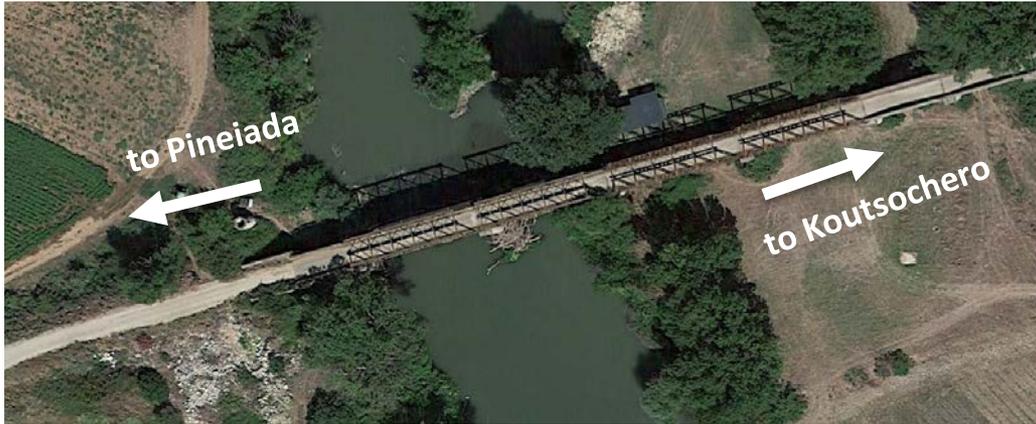
## DAMAGE TO INFRASTRUCTURES BRIDGES

Bridges are usually equipped with expansion joints in order to effectively overcome the impact of creep, shrinkage and thermal effects. Bridge structures are at risk of experiencing earthquake-induced pounding between adjacent decks or between the deck and the adjacent abutment. This pounding is attributed to the presence of these expansion joints, which are usually a few centimeters wide.

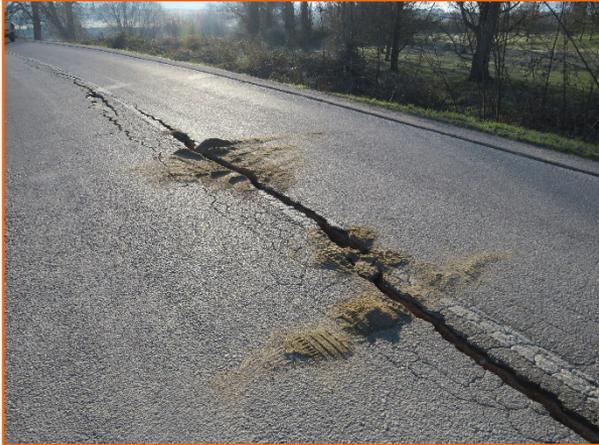
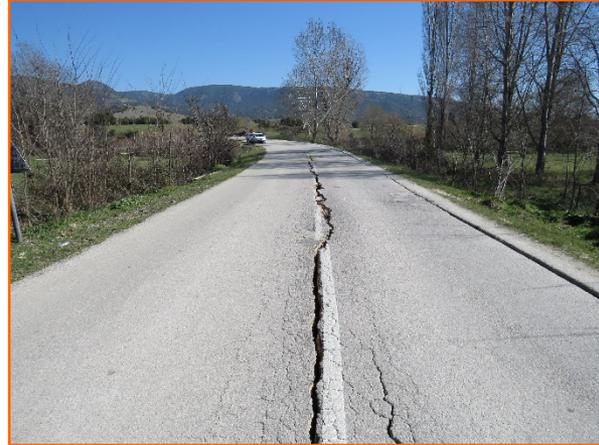
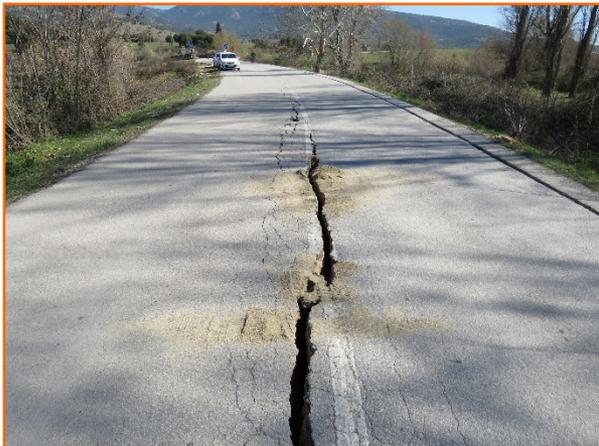
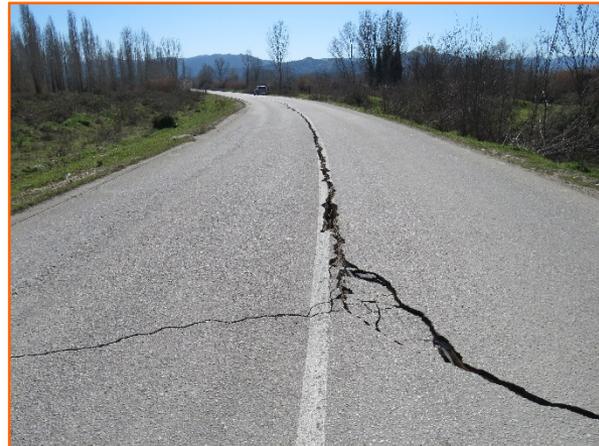
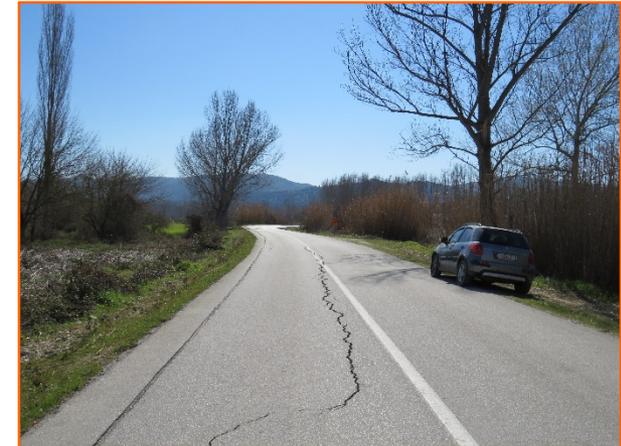
## DAMAGE TO INFRASTRUCTURES ROAD NETWORK

Damage to road leading from Mesochoiri to Vlachogianni was attributed to the earthquake ground motion and to the generated liquefaction phenomena affecting the area between the aforementioned villages.

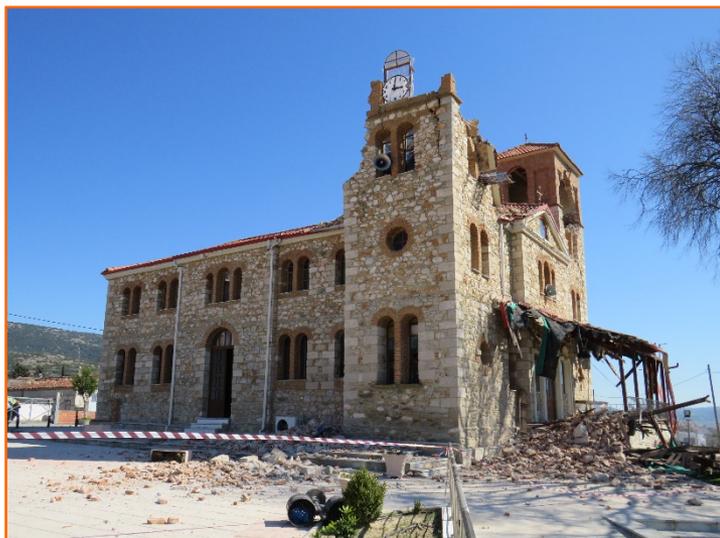
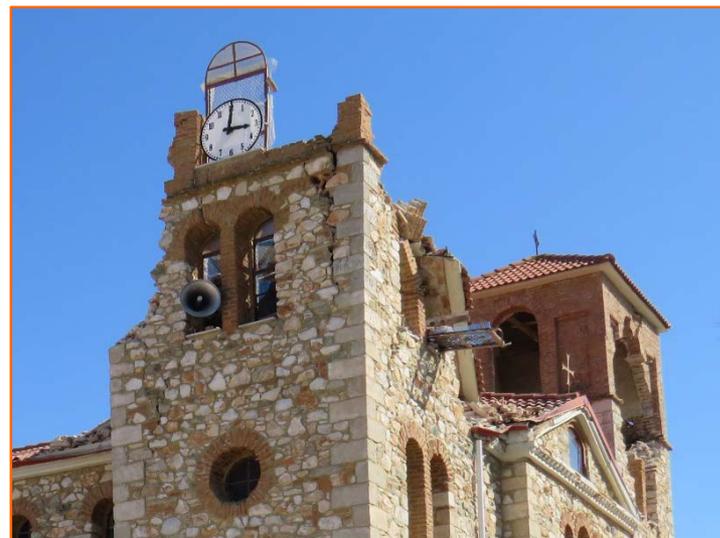
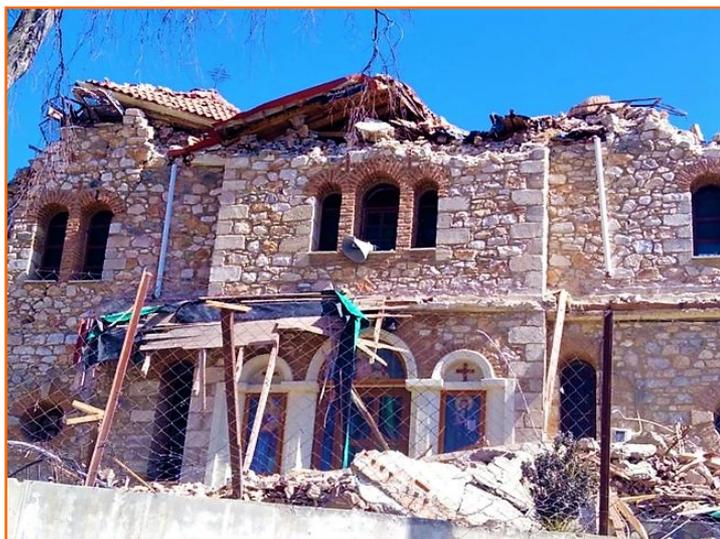
Churches in the earthquake-affected area suffered damage to the load-bearing masonry walls, arches, roofs, plasters and their bell tower.

- ▲ Characteristic damage induced by the first earthquake in the Ayios Dimitrios church in Mesochori village.
- ◀ Damage was aggravated by the second earthquake, which was generated the next day.

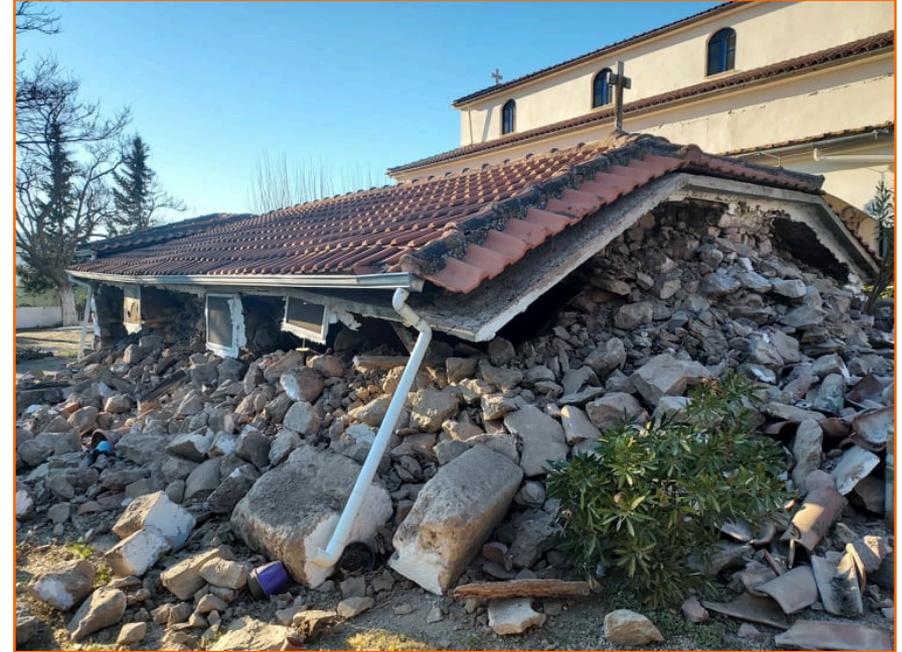
Partial and total collapse of the old and new masonry churches of Agios Nikolaos in Koutsochero village. The old structure completely collapsed, while the new one suffered collapse of its walls behind the altar.

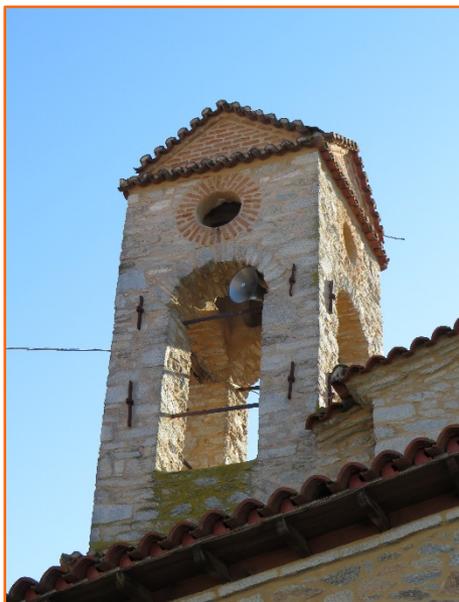
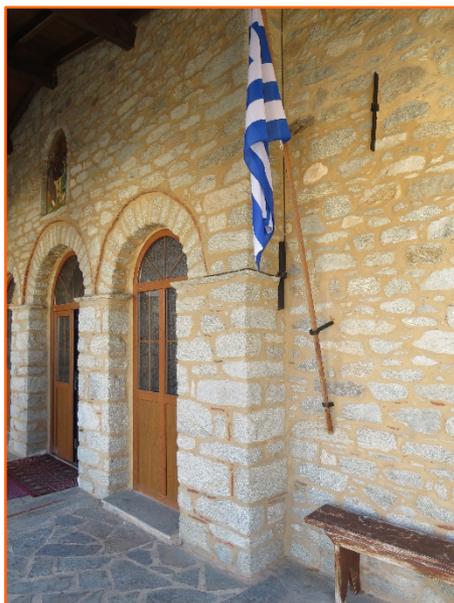
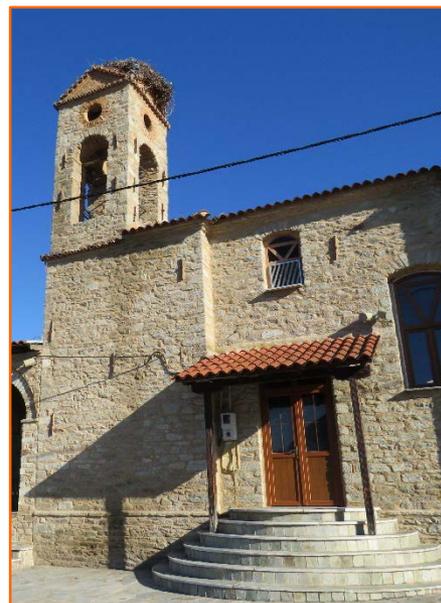
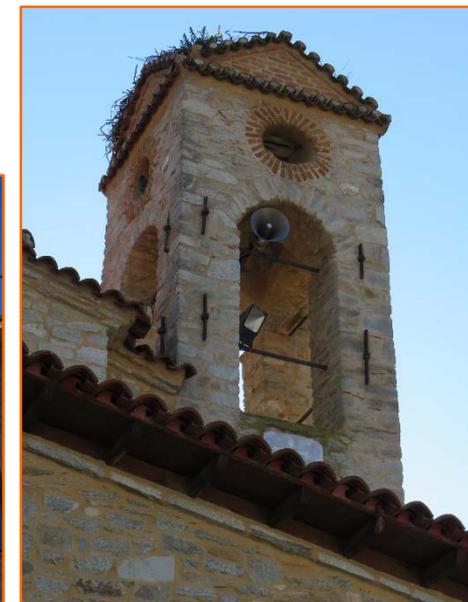
Agia Triada orthodox church  
in Vlachogianni village

The seismic performance of churches depends on the geological formation of their foundation and on their strengthening. The church in Vlachogianni village remained untouched by the earthquakes. It is founded on alpine formations and moreover it has been reinforced with the installation of steel ties in the bell tower and in the other parts of the construction. The steel ties are placed in critical key points for the stability of the structure.

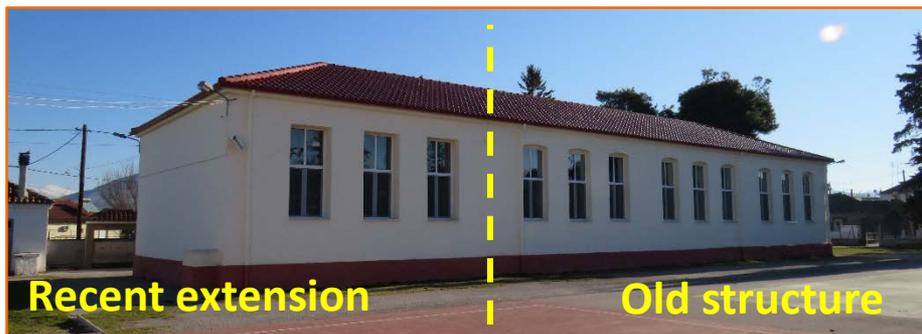
The primary school of Vlachogianni village, where cracks were formed between the old structure and its recent extension due to their different dynamic characteristics. This problem is frequently observed. The solution is simple: either we build the new structure at a distance from the old one, or we adequately tie together the two structures, after a proper structural design.
