# Newsletter of **Environmental, Disaster, and Crises Management Strategies**

Issue No.22 | March 2021

## The early March 2021 Thessaly earthquake sequence

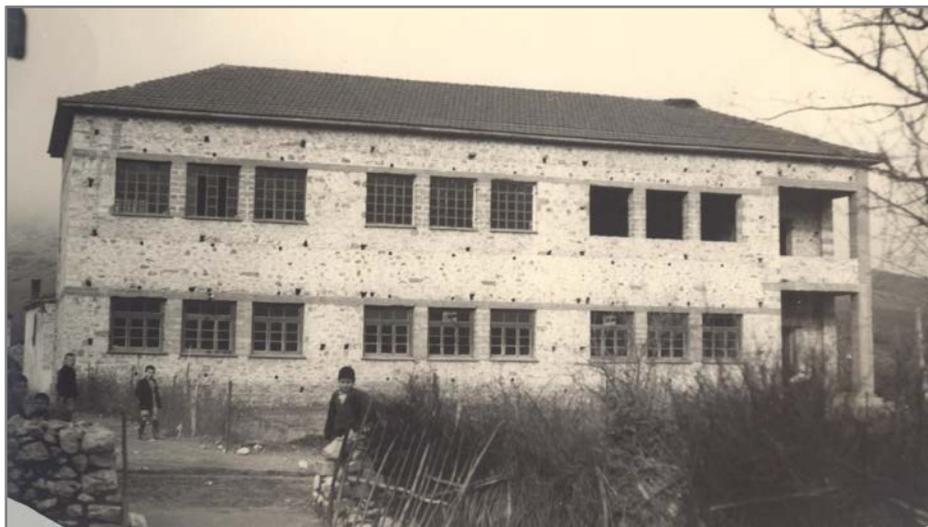
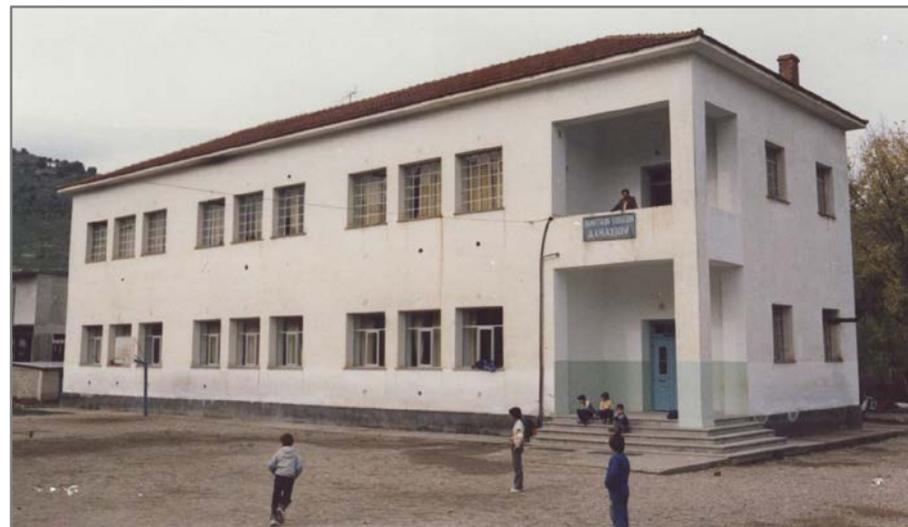
The primary school in Damasi village is an over 80-year-old building with load-bearing masonry. It suffered severe structural damage due to the Mw 6.3 earthquake comprised partial collapse of its walls and was on the verge of total collapse after the earthquake.

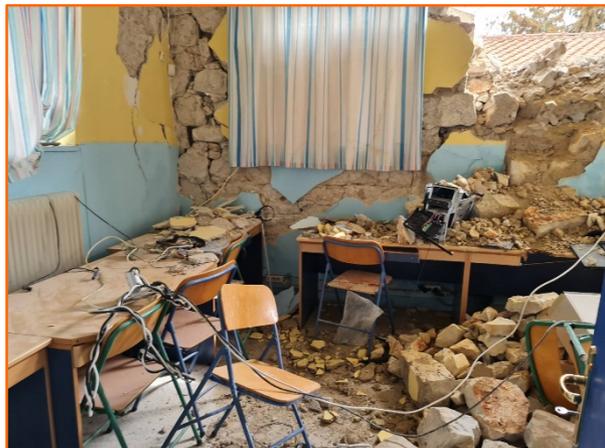
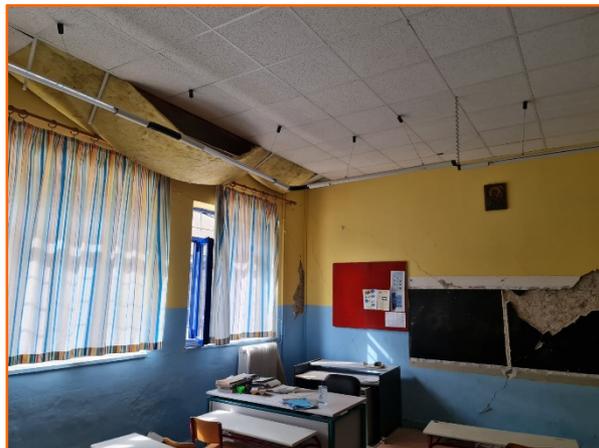
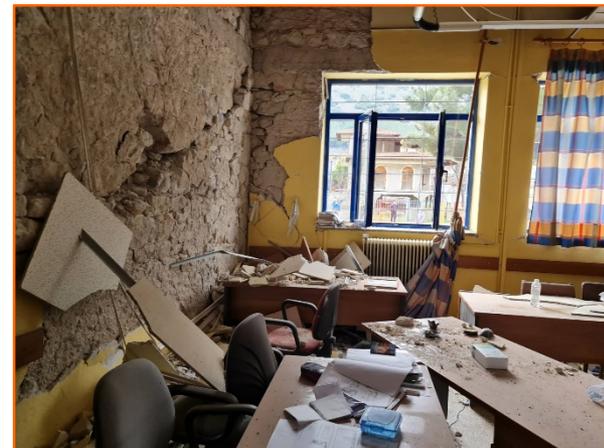
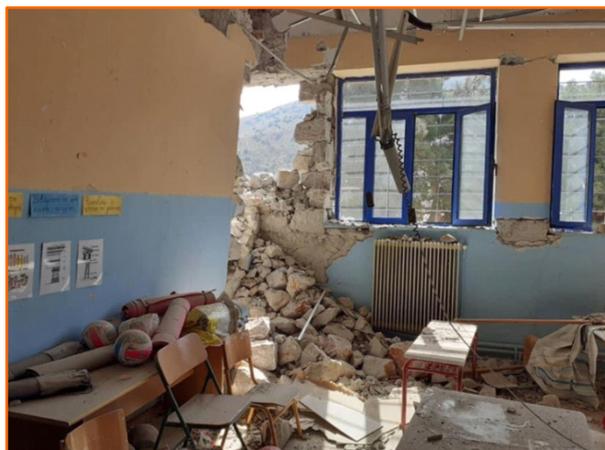
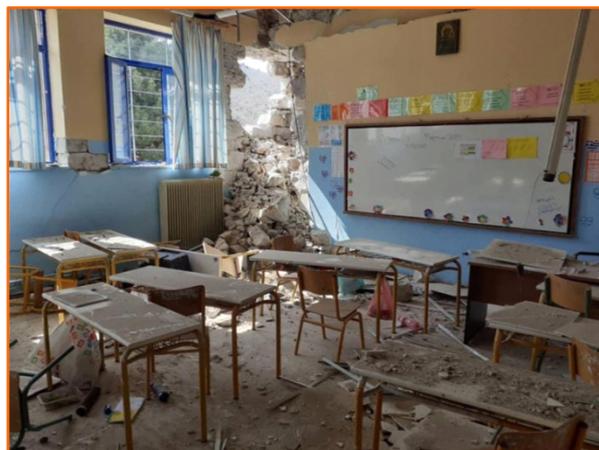
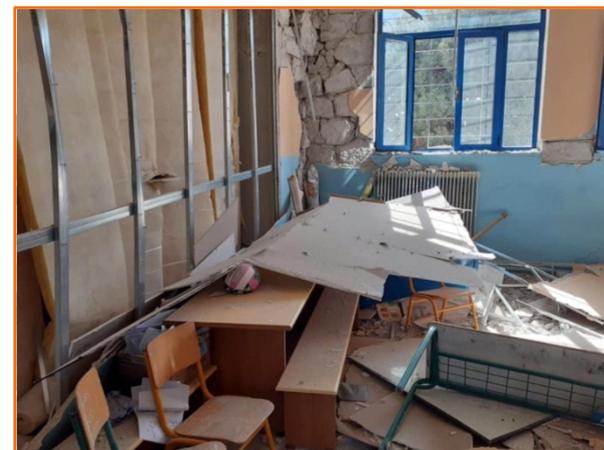
Views of the earthquake-generated building damage from the interior of the elementary school in Damasi village presented in the previous page. The masonry walls partially collapsed affecting only the school equipment.

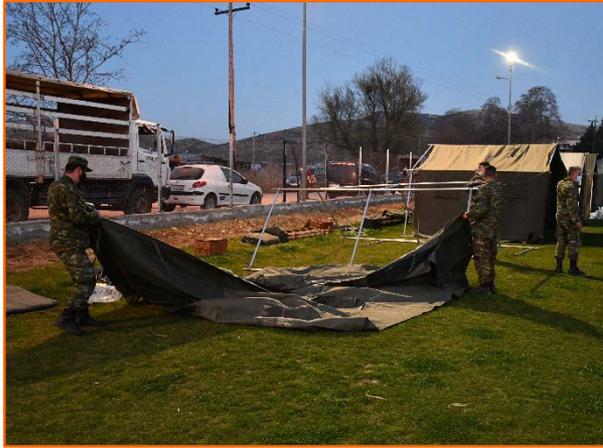
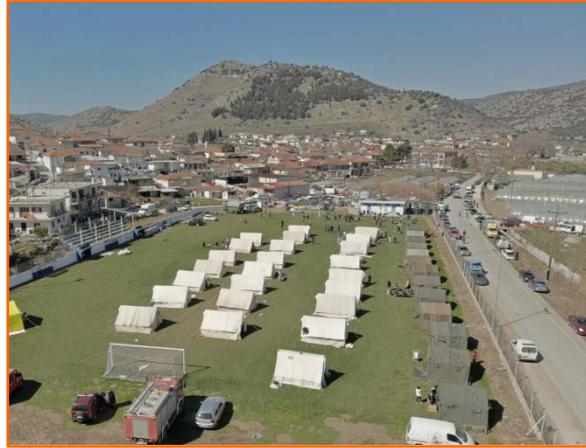
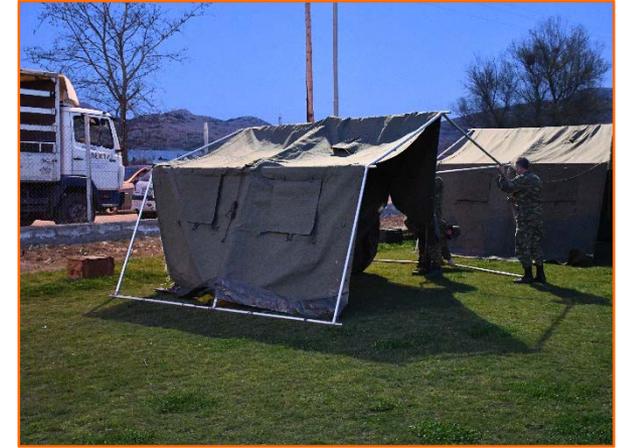
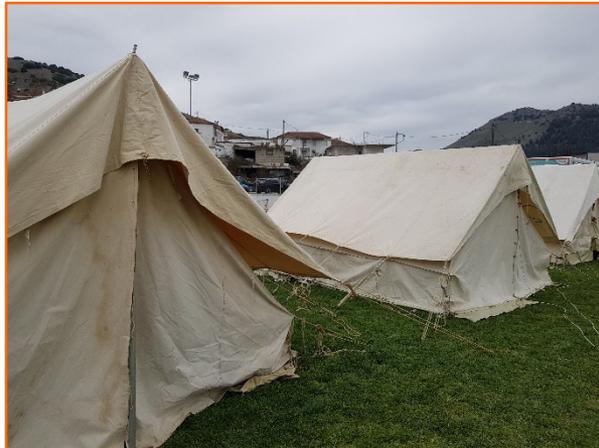
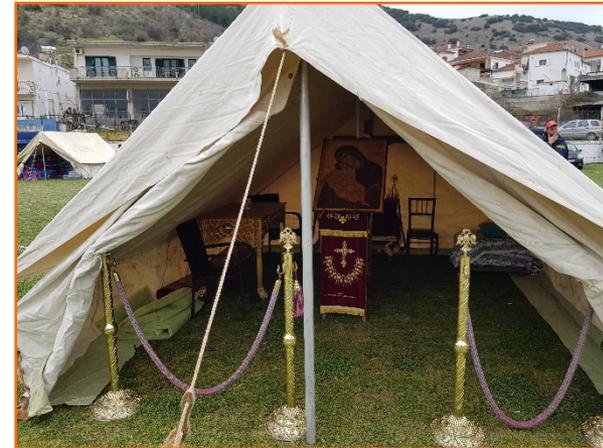
Emergency shelters were established based on the existed open spaces. They were mostly military type tents in open air spaces including stadiums and open municipal spaces. The authorities involved in the earthquake disaster management along with the contribution of the Hellenic Armed Forces provided homeless or frightened population with emergency supplies during their staying in shelters.

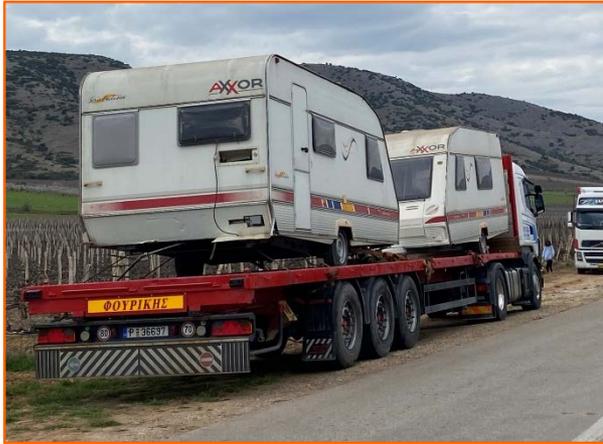
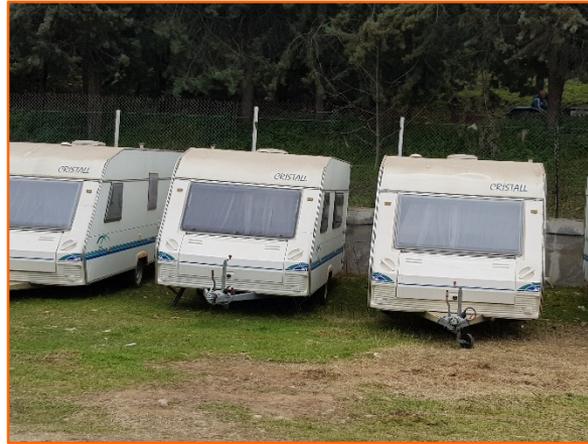
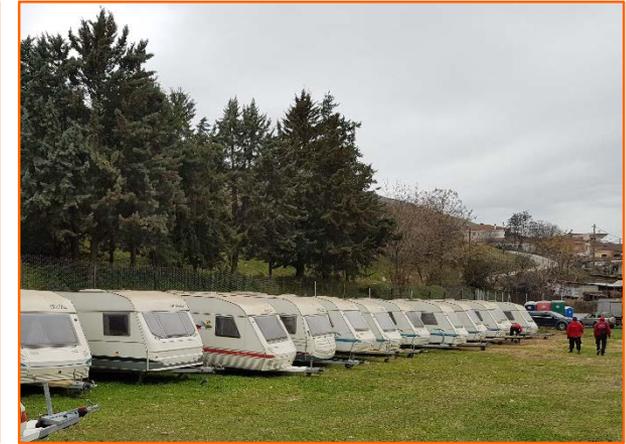
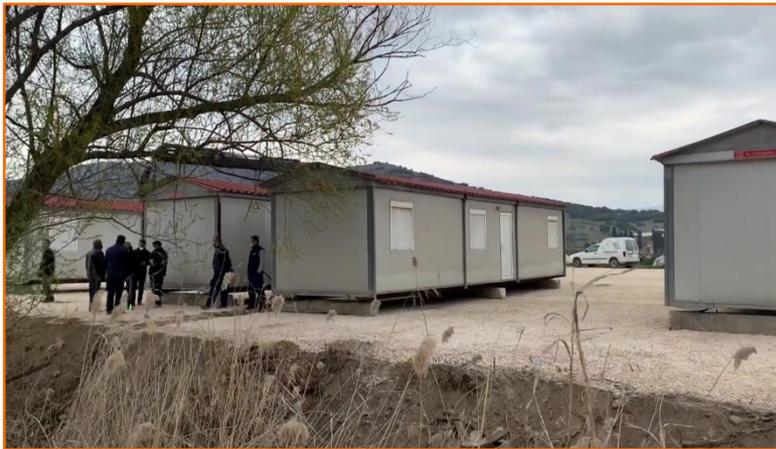
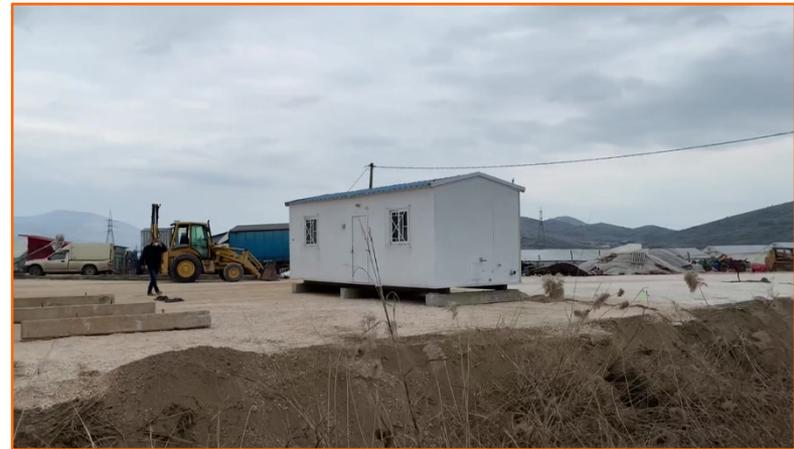
In addition to the tents used in the emergency shelters, camper vans were used. They were installed in a specially designed municipal area or in safe yards of damages houses in affected villages of the area. Few days later, container-type houses were also set up for the temporary housing of the affected people who lost their properties.

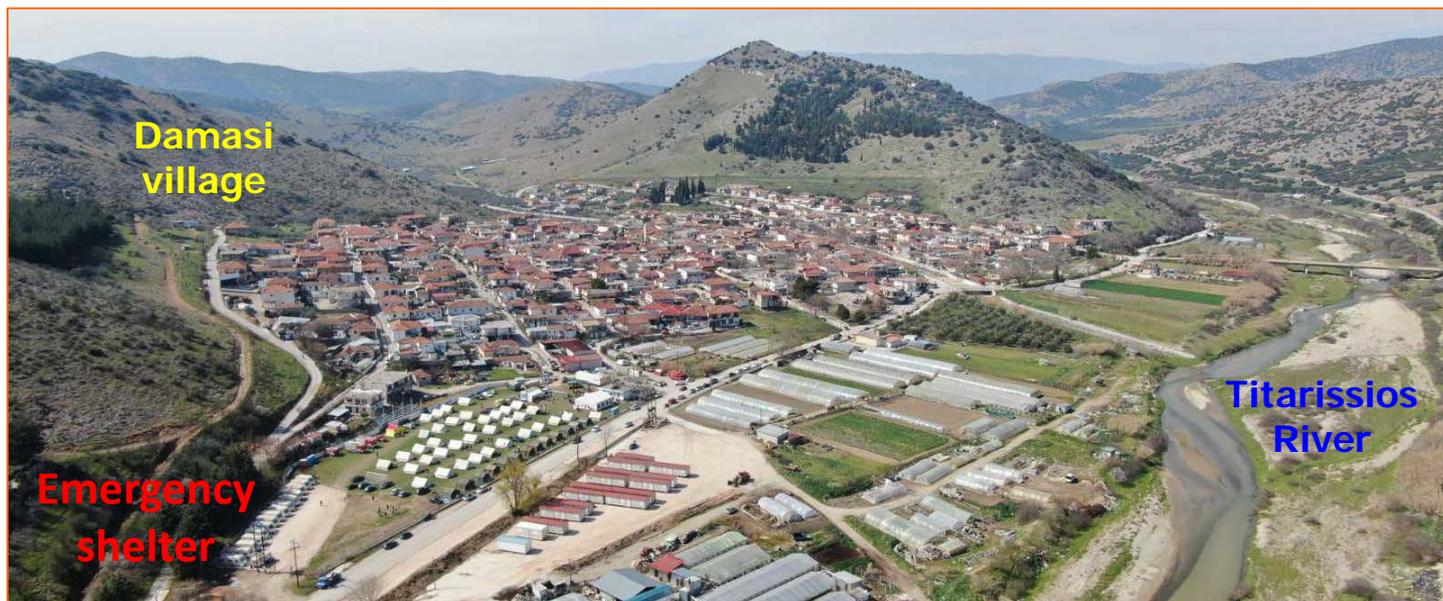
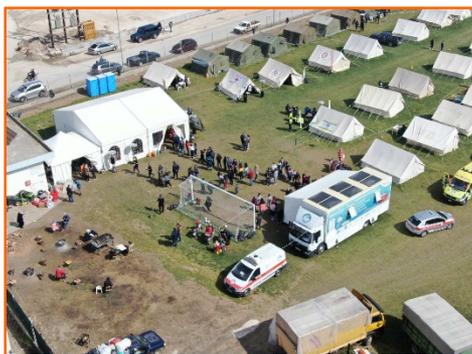
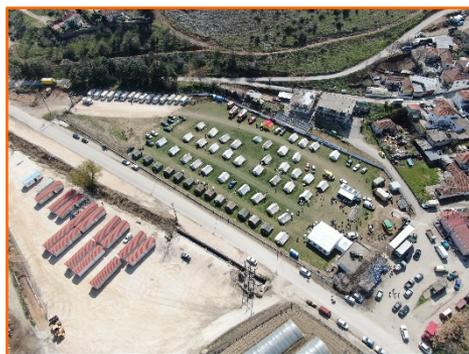
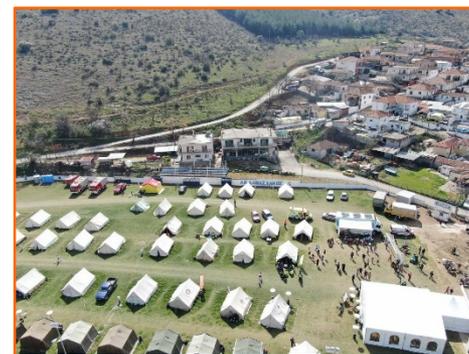
The location of emergency shelters serves two primary functions: providing temporary residence where affected people can avoid secondary damage such as fires, floods and diseases, and allowing first responders to efficiently perform search and rescue operations.
